WASHINGTON COUNTY, MARYLAND ADA SELF EVALUATION BUILDINGS, FACILITIES, AND PARKS 2023 UPDATE

Washington County performed a Self-Evaluation of County owned buildings, parks, and facilities.

The initial Self-Evaluation has been updated with new data collected for this update. The results of the survey were used to develop a Transition Plan to address all non-compliant facilities identified.

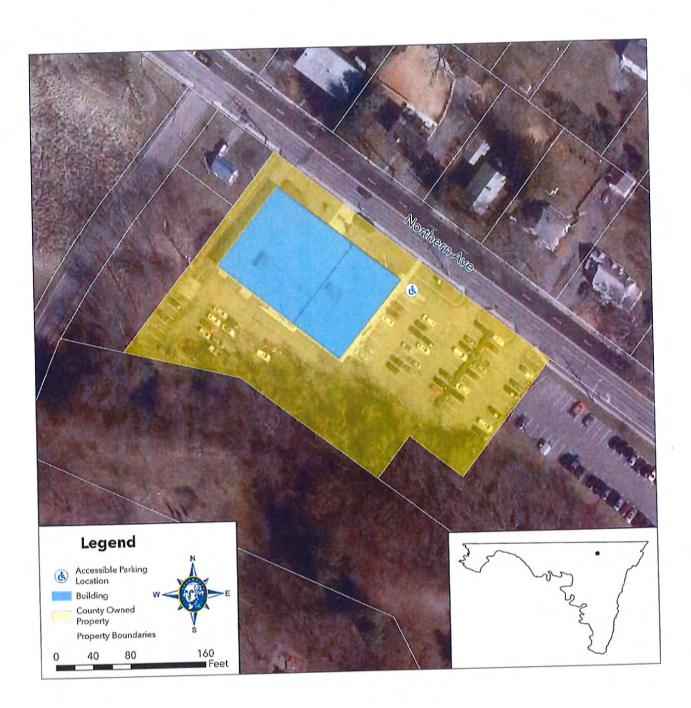
Washington County Administrative Annex

Room/Space Priority Key Note Accessibility Deficiency ADA Code Reference Accessible Route 4H 5-2, 5-9 Three accessibke parking spaces; 4 spaces required (82 208.2, 502.6, 503.6, 703 Accessible Route 4H A-7 The cross slope is steeper than 2% in the area of the van accessible Route 4D5.2 Accessible Route 7M A-11 1/2". The door threshold edge is higher than 1/4". Measured 7.5% 404.2.5 Accessible Route 9L A-9 There are no signs at the inaccessible toilet rooms. 703 Soap dispenser outside accessible toilet rooms. Soap dispenser outside accessible reach range. Installed higher than 44 inches above the floor. Installed at 47.5 308.3, 604.7 Doom - Towel Dispenser 9L A-25 Inches. 308.3, 604.7 Doom - Water Closet 7M A-24 Centerline of water closet is greater than 18 inches from the side wall. Installed at 19 inches. 306, 606.2, 606.3 Doom - Stalls 9L A-25 The door is not self closing and needs pulls on both sides of the door. 604.8.1.1			Public Men's Toilet Room			Toilet Room - Accessible Route

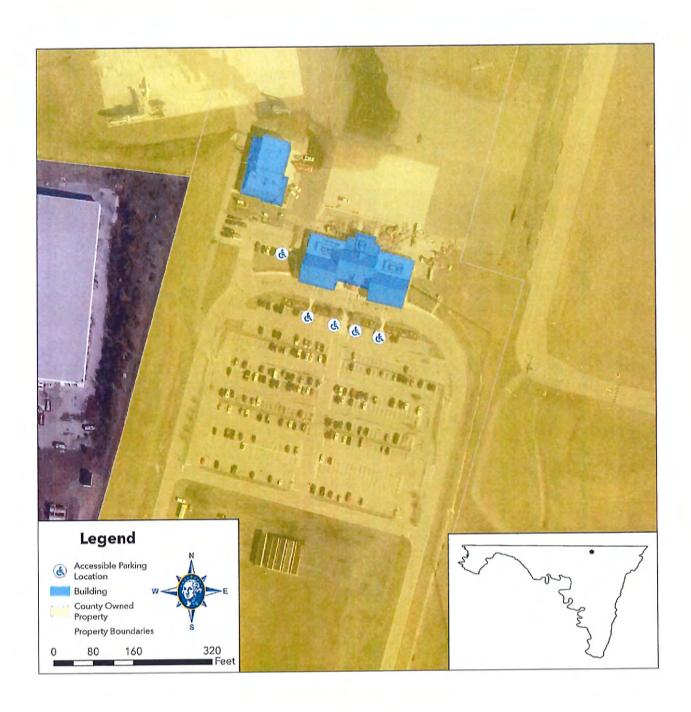
Hagerstown Regional Airport

Terminal Men's Toilet Room			
\$850	Relocate toilet to compliant distance in reference to side wall. Relocate grab bars to compliant locations.	604.2, 609.4, 609.3, 604.5.2	Center line of water closet is more than 18" from sidewall (20"). Grab bars are mounted higher than 36" from floor (36.5"). Less than 12" of clearance above side grab bar (9.5"). Rear grab bar does not extend at least 24" to open side of water closet (20").	A-24, A-25	7M	Water Closets
						Soap Dispensers and Hand Dryers
\$20	Replace signs with signs that include the international symbol of accessibility.	703	Toilet room is not marked with international symbol of accessibility.	A-9	9L	Toilet Room - Accessible Route
			Women's Toilet Room			
						Toilet Compartment (Stalls)
\$850	Relocate tollet to compliant distance in reference to side wall. Relocate grab bars to compliant locations.	604.2, 609.4, 609.3, 604.5.2	Center line of water closet is more than 18" from sidewall (19"). Side grab bar is mounted higher than 36" from floor (36.5"). Less than 12" of clearance above side grab bar (2.5"). Rear grab bar does not extend at least 24" to open side of water closet (20").	A-24, A-25	7M	Water Closets

Soap Dispensers and Hand Dryers
\$10	Replace signs with signs that include the international symbol of accessibility.	703	Toilet room is not marked with international symbol of accessibility.	A-9	J6 .	Toilet Room - Accessible Route
			Men's Toilet Room			
						benches
						Seating
						Fire Alarm Systems
						Controls
						Signs
						Elevators
						Ramps
						Interior Accessible Route
\$15,000	Possibly repave or orientent level ground area at exterior manuvering area of entrance.	404.2.4.4	Clear floor space in exterior manuvering area exceeds 2.08% (5.3%).	A-3	4H	Main Entrance
						Curb Ramps
Included in Main Entrance Cost*	m=	206	Route has a running slope steeper than 5.0% (6.3%).	S-3	4	Exterior Accessible Route
\$500	Repaint accessible parking area to ensure that van accessible spaces are at compliant size. Add signage designating "van 502.2, 502.3.3, 502.4, 502.6 accessible" spaces and to discourage parking in access aisles. When parking lot is repaved, make sure that it is withing compliant slope.	502.2, 502.3.3, 502.4, 502.6	Parking space and van accessible aisle do not total a minimum 16/192", accessible aisle is 60"(compliant) however parking space is 128" (132" minimum). Access aisles are not markes as to discourage parking in them. Cross slope at parking space is more than the minimum 2.08% (2.8%). Signs do not read "van accessible" at van accessible spaces.	S-2, S-9, S-10	4Н	Parking

1	Total					de live de di lorie
-						Service Counters
						Drinking Fountain
-						Toilet Compartment (Stalls)
	Relocate grab bars at compliant height from floor.	609.4	Grab bars are mounted higher than 36" from floor (37").	A-24	J6	Water Closets
						Soap Dispensers and Hand Dryers
	Replace signs with signs that include the international symbol of accessibility.	703	Toilet room is not marked with international symbol of accessibility.	A-9	.9L	Toilet Room - Accessible Route
			Terminal Women's Toilet Room			
						Toilet Compartment (Stalls)
	Replace toilet seat to that top of seat is at complaint height from floor. Relocate grab bars at compliant height from floor.	604.2, 609.4	Toilet seat is higher than 19" above floor (20"). Grab bars are mounted higher than 36" from floor (37").	A-24	7M	Water Closets
						Soap Dispensers and Hand Dryers
	Replace signs with signs that include the international symbol of accessibility.	703	Toilet room is not marked with international symbol of accessibility.	A-9	91	Tailet Room - Accessible Route

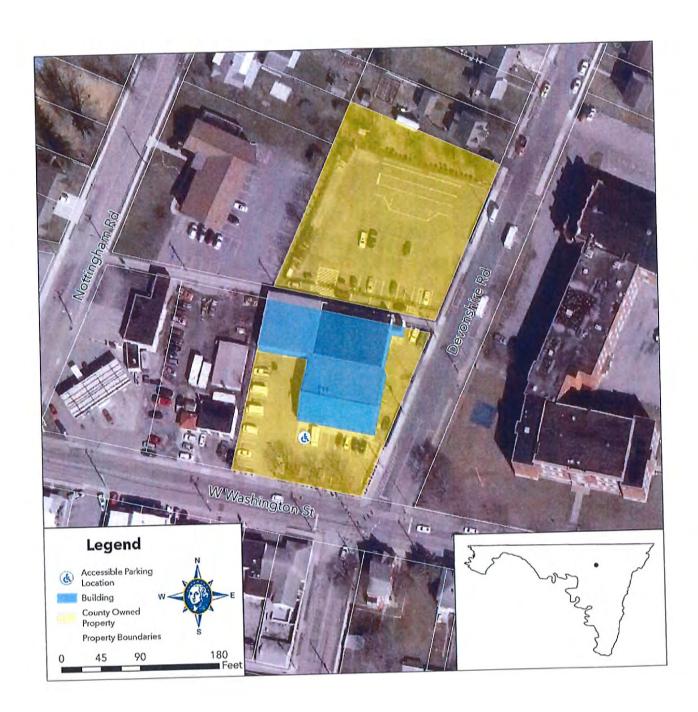
\$34,410	Total					
\$1,500	Restructure current Service Counter.	904.4.1	Service Counter is more than 36" above the floor. (41.5")	A-14	6M	Service Counters
						Drinking Fountain
						Toilet Compartment (Stalls)
\$60	Replace or lower water closet seat so that is has a compliant height. Replace rear grab bar with longer bar to extend to compliancy.	604.9, 609.4	Height of water closet greater than 19" above floor (20") Grab bar does not extend 24" to open side of toilet (19")	A-25	7M	Water Closets
\$0	Relocate Hand Dryer / Towl Dispenser to location within accessible reach.	308.2.1	Operable parts of hand dryer / towel dispenser are out of designated operable ranges. More than 48" above floor (53.5")	A-25	9L	Soap Dispensers and Hand Dryers
\$800	Relocate Sign to wall on latch side of the door. Replace door hardware. Provide pipe wrap. Relocate coat hook to spot on door 606.5, 604.8.3 within accessible reach.	703, 404.2.7, 606.5, 604.8.	Sign not mounted on the wall on the latch side of the door (on door). Door is equiped with hardware that requires tight grasping, pinching, or twisting of the wrist to operate. Pipes below lavatory are not insulated or configured to protect against contact. Cost hook is greater than 48° above the ground (68°).	S-9, A-21, P-6, A-27	W.	Toilet Room - Accessible Route

Benches
	flashing lights and audible signals.					Seating
\$1,000	Replace fire alarm systems to have both	702	Fire Alarm System does not have flashing lights	E-2		Fire Alarm Systems
\$15,000	Relocate control operables to within accessible reach.	309.3	Operable parts are higher than 48" (50.5")	T	5M	Controls
\$450	Replace signs that do not have raised characters or braille as needed and relocate signs to latch side of door. (Approx 35 new signs)	703	Signs do not have raised characters and braille. Some signs are mounted on doors and not on the wall on the latch side of door.	9-9	SM.	Signs
						Elevators
						Ramps
\$250	Replace the door threshold.	404.2.5	Door threshold is great than 1/4" (1")	A-1	7M	Interior Accessible Route
\$250	Replace the door threshold.	404.2.5	Door threshold is great than 1/4" (1")	A-1	7M	Main Entrance
\$15,000	Possible extended curb ramp out into accessible aisle to create 60" x 60" landing space?	304	Level landing at top of curb ramp is not at least $60" \times 60"$.	A-7	2H	Curb Ramps

Exterior Accessible Route
\$100	New Signs need to be installed along with existing signs to be placed at 60" above the ground.	502.6	Access aisles are not marked to discourage parking. Existing signs not a correct height. Signage does not say "Van Accessible".	9-5	6M	Parking
Cost	Recommendation	ADA Code Reference	Accessibility Deficiency	Key Note	Priority	Room / Space
		D 21740	1000 West Washington Street, Hagerstown, MD 21740			
			County Commuter Transit Building			
						Buildings / Facilities
						Accessibility Assessment
						Washington County Government

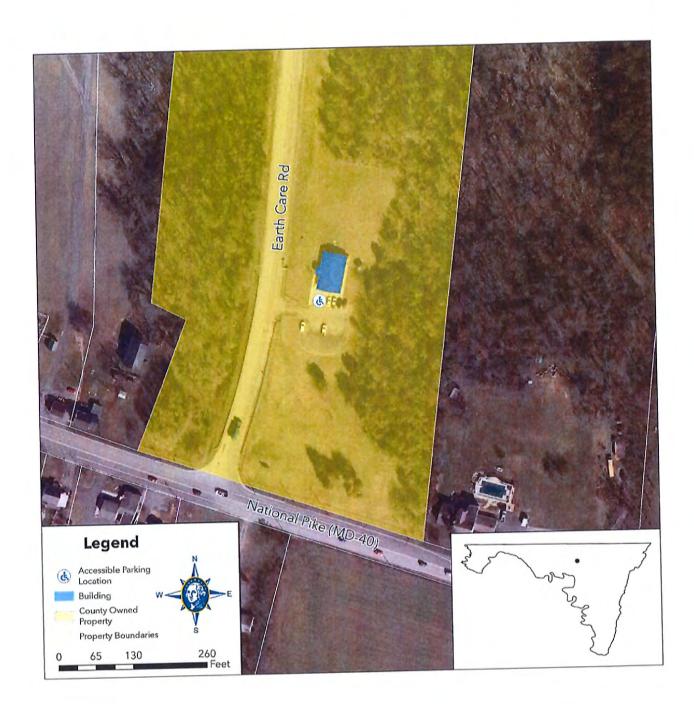
Forty West Landfill Office Building

Washington County Government						
Accessibility Assessment						
Buildings / Facilities						
			andfill Office			
			13630 Earth Care Board Daggerstours MD	OVER		
			12630 Earth Care Road, Hagerstown, MD 21740	21740		
Room / Space	Priority	Key Note	Accessibility Deficiency	ADA Code Reference	Recommendation	Cost
Parking	6M	S-2	No markings so as to discourage parking in access aisle.	502.3.3	Install sign to discourge parking in access	\$100
Exterior Accessible Route						
Curb Ramps						
Main Entrance	111	A-2	Interior Door of two-door entrance has a closing speed that is faster than 5 seconds from 90 to 12 degrees.	404.2.8	Adjust door closing mechanism to a compliant speed.	\$0
Interior Accessible Route	6M	A-13, A-2	Multiple objects protruding more than 4" into path. Interior Door of two-door entrance has a closing speed that is faster	307.2, 404.2.8	Relocate protruding objects outside of accessible route. Adjust door closing	\$0

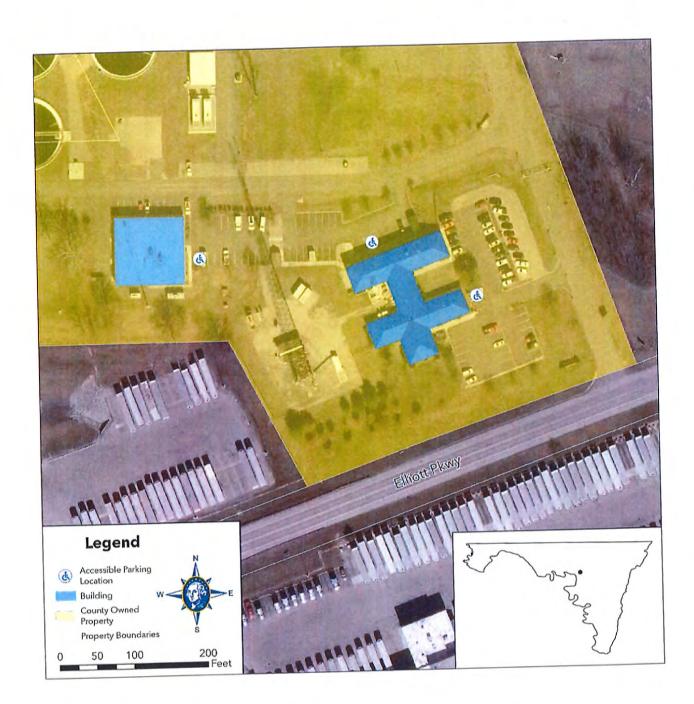
Soap Dispensers and Hand Dryers	Toilet Room - Accessible Route		Benches	Seating	Fire Alarm Systems	Controls	Signs	Elevators	Ramps	Interior Accessible Route	Main Entrance	Curb Ramps	Exterior Accessible Route	Parking		Room / Space			Buildings / Facilities	Accessibility Assessment	Washington County Government
										7M	7M			4H		Priority					
										A-2	S-9, A-2			S-9, S-2		Key Note		Was			
		Men's Bottom Floor Toilet Room								Door takes long than 5 seconds to close from 90 to 12 degrees	Not all accessible entrances have signs indicating the nearest accessible entrance. Door takes more than 5 seconds to close from 90 to 12 degress			Inadequate Signage. Access aisles are not marked to discourage parking. Running slope exceeds 2.08% (6.3%). Existing signs not a correct height. Signage does not say "Van Accessible".	Bottom Entrance	Accessibility Deficiency	16232 Elliott Parkway, Williamsport, MD 21795	Washington County Water Quality / Emergancy Services Buil

Cross slope of exterio Exterior Accessible Route 4H 5-3 (2.3%).	Parking Parking AH AH S-2 identified as "van accessible".		6M A-14	Drinking Fountain	Toilet Compartment (Stalls)	Water Closets 9L A-25 Both side (37") and resis greater than 36" from is located less than 7" closet (0").	Soap Dispensers and Hand Dryers	9L A-9	Women's Bo	Toilet Compartment (Stalls)	Height of toilet seat is side (36.5") and rear (3 greater than 36" from open side of water closets 7M A-25 (0").
	Cross slope of exterior entrance route exceeds 2.08% (2.3%).	Inadequate number or accessible parking spaces provided. No signage that identifies or discourages parking in access aisle. Signage is not a minimum 60" above ground (49.5"). No accessible spaces are identified as "van accessible".	Top Entrance	Lowest point of counter is higher than 36" above the floor (42"). Service Counter is not 36" long.			Both side (37") and rear (37") grab bars top of surface is greater than 36" from floor. Toilet paper dispenser is located less than 7" from the front of the water closet (0").		Non-permenant cabinet is located infront of sign designating the room as an accessible toilet room.	Women's Bottom Floor Toilet Room		Height of toilet seat is greater than 19" (19.5"). Both side (36.5") and rear (37") grab bars top of surface is greater than 36" from floor. Flush control is not on open side of water closet. Toilet paper dispenser is located less than 7" from the front of the water closet (0").

404.2.8	216.6, 404.2.8			502.3.3, 302, 502.6		ADA Code Reference		uilding			
										Adjust door hardware so that closing speed is compliant.	Install signs at inaccessible entrances indicating the nearest accessible entrance. Adjust door hardware so that closing speed is compliant.			New Signs need to be installed along with existing signs to be placed at 60" above the ground.		Recommendation					
					E					\$0	\$75			\$100		Cost

403.3	208.2, 502.3.3, 502.6		904.4.1			609.4, 604.7		216			604.4, 609.4, 604.6, 604.7
Recommendation: install	Level out concrete on exterior accessible route so that cross slope is less than 2.08%.	Potentially add accessible parking spaces. Add signage identifying a space as "van accessible" and access aisle and discouraging parking in access aisle. Install signage at least 60" above ground.		Reorient service counter (service window) so that there is a portion 36" in height that is 36" in length.			Relocate grab bars to location at compliant height. Relocate toilet paper dispenser to location compliant in reference to water closet location.		Relocate cabinet so that it does not block access to signage.			Replace toilet seat to seat that allows for compliant height. Relocate grab bars to location at compliant height. Relocate flush control to open side of water closet. Relocate toilet paper dispenser to location compliant in reference to water closet location.

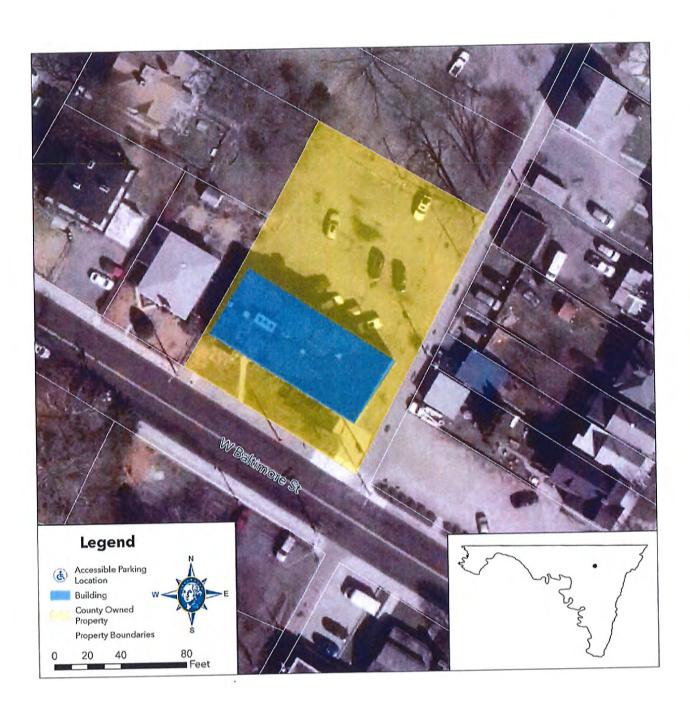
Washington County Government Accessibility Assessment Buildings / Facilities						
			Dwyer Center			
			116 West Baltimore Street, Hagerstown, MD 21740	1740		
Room / Space	Priority	Key Note	Accessibility Deficiency	ADA Code Reference	Recommendation	Cost
Parking	2H	5-2, 5-9	Parking Lot (approx. 30 spaces) is not marked. No handicap or van accessible spaces are adequately marked and no signage for handicap spaces is present.	502	Have parking lot painted with space closest to asscessible route deemed as handicap/van accessible with space and asile totalling 16' wide. Have handicap signage installed at space and aisle at compliant height	\$900
Exterior Accessible Route	2Н	23	Running Slope too steep at certain points (6.3%)	403.3	Level out pavement near water drainage point	\$1,500
Curb Ramps	2Н	S-7	Running slop of Curb Ramp too steep (14.9%)	406.2	Alter curb ramp to compliancy	\$5,000
Main Entrance	7M	S-1, S-9	No handicap signage at main entrance. (Also no sign indicating accessible route at non-accessible entrances) Door Closing Speed is too fast.	206, 404.2.8	Adjust Door Closing Speed and install handicap signage at building entrances	\$100

Red text not included in cost calculation.*					
\$65,600	Total					
\$200	Install ADA complaint countertop under window. (Replacing wooden shelves currently being used)	305	No clear floor space under counter (shelves).	A-14	7M	Service Counters
\$1,200	Replace drinking fountain with ada compliant drinking fountain. (Or remove drinking fountains)	602.2, 602.4, 602.5	More than 25" of clear floor space under drinking fountain (27"). Spout outlet is lower than 38" above the floor (35.5"). Spout outlet is less than 15" from the rear of the drinking fountain (7.5").	S-14	M8	Drinking Fountain
						Toilet Compartment (Stalls)
\$350	Replace toilets that have accessible seat 609.1, 604.4, 604.6, 604.8.2, Relocate toilet paper dispensers to 7" in front of water closet.	609.1, 604.4, 604.5, 604.8.2, 604.7	No grab bars present. Height of water closet is less than 17" at top of seat (16"). Flush control for the toilet is not on the open side of water closet. Toilet paper dispensers are less than 7" in front of water closet (1").	A-24	6M	Water Closets

\$250	Relocate soap dispenser and hand dryer to accessible reach. Lower sink if possible to accessible height.	308.2.2, 606.3	Soap dispenser operable parts are more than 44" above the floor (50"). Hand Dryer operable parts are more than 44" above the floor (47"). Lavatory more than 48" above floor (50").	A-23, A-25	7M	Soap Dispensers and Hand Dryers
\$20,000	Install compliant sign on latch side of door. Expand door opening and install door at least. 32" wide. Lower mirror height to compliancy. Replace faucets. Cover or insulate pipes to protect from contact. Reorient or design bathroom (possibly extend out towards lobby) to more room for compliant turn space and door with.	703, 404, 206, 304.3, 305.3, 306.2.2, 606.4	Sign is not on latch side of door and does not have raised characters and braille and its lowest character is is more than 60" above floor (56"). The door is less than 32" wide (30.5") when open at 90 degree. Clear path to fixtures less than 36" (32"). Not adequate 60" x 60" turning area. Mirror more than 40" above ground (48"). Clear space on approach to lavatory not 48" long (43.5"). Less than 17" of clear floor space under lavartory (8"). Pipes are not insulated or configured to protect against contact. Faucet requires tight grasping to operate.	5-9, A-10, A- 11, A-19, A-28, P-5, P-6	6M	Toilet Room - Accessible Route

-			Women's Toilet Room			
						Toilet Compartment (Stalls)
\$350	Replace toilets that have accessible seat height and flush to open side of water closet. Relocate toilet paper dispensers to 7" in front of water closet.	609.1, 604.4, 604.8.2, 604.7	No grab bars present. Height of water closet is less than 17" at top of seat (16"). Toilet paper dispensers are less than 7" in front of water closet (1").	A-24	6M	Water Closets

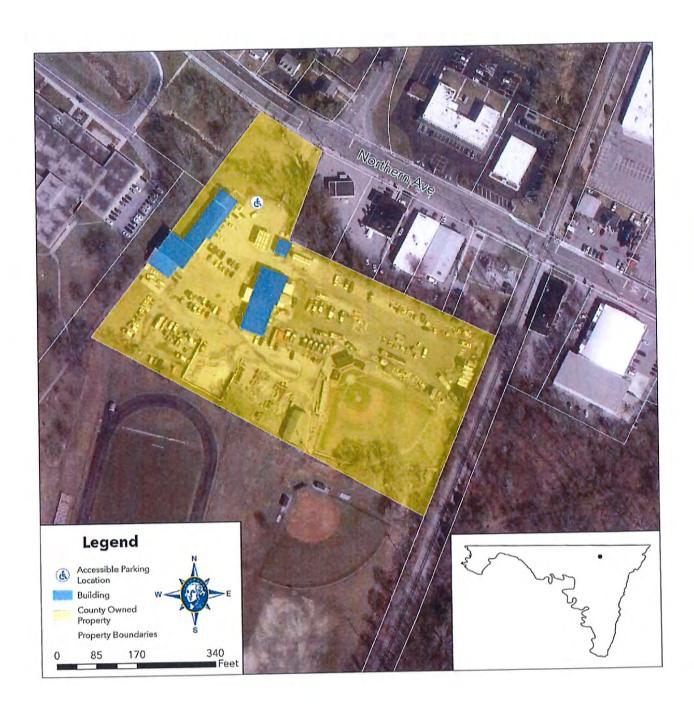
Washington County Central Section Highways Building

Washington County Government Accessibility Assessment Buildings / Facilities			Central Section Highways Building		
			Central Section Highways Building	40	
Room / Space	Priority	Key Note	Accessibility Deficiency	ADA Code Reference	Recommendation
Parking	24	S-2, S-9	No handicap or van accessible spaces and access aisles are adequately marked. No Present signage for access aisle is present. Signage does not read "van accessible" and is not a minimum 60" above ground (43.5").	502	Have parking lot painted with space closest to asscessible route deemed as handicap/van accessible with space and asile totalling 16' wide. Have handicap signage installed at space and aisle at compliant height.
Exterior Accessible Route					
Curb Ramps					
Main Entrance	44	A-2, A-9	Inaccessible entrances do not have signage indicating the location of the nearest accessible entrance. Accessible entrance does not have signage indicating entrance as accessible with the "International Symbol of Accessibility". There is less than 18" of maneuverable clearance beyond latch side of door. Door threshold exceeds .75" (1"), Door closing speed is too fast.	216.6, 404.2.4.1, 404.2.5, 404.2.8	Relocate office fixture to allow compliant maneuverable space beyond latch side of door. Install signage indicating accessible entrances and their location at inaccessible entrance. Replace door threshold. Adjust door closing speed to compliant speed.

\$81,835	Total					
						Service Counters
						Drinking Fountain
			Women's Toilet Room is not along an accessible route.* - no signage indicating location of other restroom which is a Men's Toilet Room.	no signage indi	ccessible route.* - r	Women's Toilet Room is not along an a
\$300	Install self-closing door hinges. Reorient or replace stall fixtures to allow for 60" stall depth.	604.8.2.2, 604.8.1.1	Stall door is not self-closing. With floor mounted water closet, compartment depth is not a minimum 59" deep (58").	A-21, A-25	7M	Toilet Compartment (Stalls)
\$400	Reorient piping on water closet to allow for flush controls to be on open side of water closet. Relocate toilet paper dispenser to compliant location.	604.6, 604.7	Flush control is not on open side of water closet. Toilet paper dispenser is greater than 9" from front of water closet (22").	A-24	7M	Water Closets

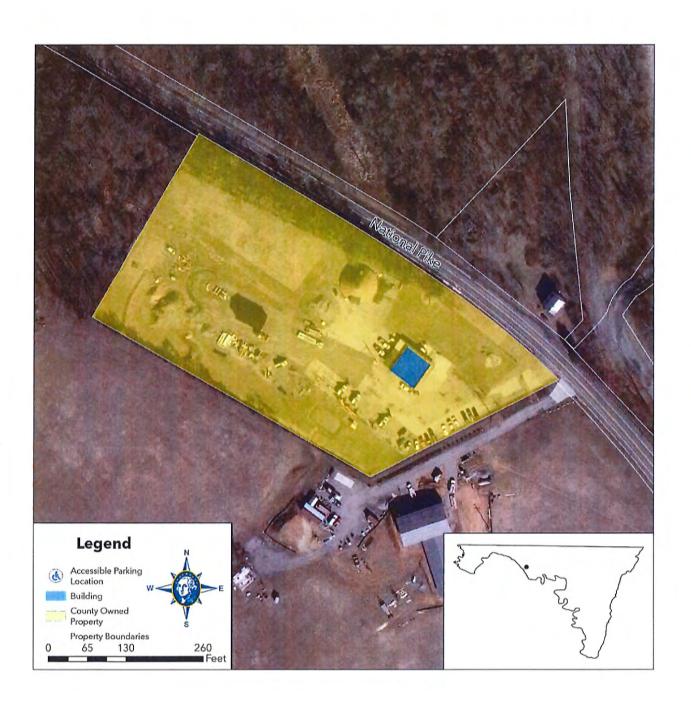
Washington County Western Section Highways Building

-						Service Counters
						Drinking Fountain
						Toilet Compartment (Stalls)
3 %	Relocate both side and rear grab bars to compliant heights and distances from walls. Relocate toilet paper dispenser to compliant location.	609, 604.5, 604.5.1, 604.5.2, 604.7	Inadeqaute clearance around water closet. Side grab bar is located less than 12" from back wall (11") and more than 36" above floor (37"). Back brab bar does not extend 24" from toilet centerline to openside (18"). Back grab bar is more than 36" above floor (37"). Toilet paper dispenser is less than 7" in front of water closet (0").	A-24	6M	Water Closets
	Install soap dispenser and relocate hand towel dispenser to compliant locations.	606, 606.1	No dispenser currently installed. Hand towel dispenser (above lavatory) is higher than 44" above floor (57.5").	A-25	6M	Soap Dispensers and Hand Dryers

-	Install complaint signage on latch side of door. Lower mirror too compliant height. Wrap/insulate pipes to protect against. contact. Relocate coat hook to complaint height. Remove shower (that is not used) to allow for compliant turning space and clear floor space for approaches to toilet room fixtures.	216, 603.2.1, 603.3, 606.2, 606.5, 603.4	Sign is not on latch side of door (on door) and does not have raised characters or braille. Not an adequate amount of floor space (60" x 60" min.). Bottom edge of mirror above countertop higher than 40" above floor (54.5"). Inadequate clear floor space for lavatory approach. Pipes are not insulated or configured to protect against contact. Coat hook greater than 48" above floor (69").	A-9, A-19, A-28, A- 22, P-6, A- 27	6M	Toilet Room - Accessible Route
						Benches
						Seating
			No fire alarm system present.		Ŧ	Fire Alarm Systems
	Relocate controls to within accessible reach.	309.3	Controls are higher than 48" above floor. (58")	M-1	6M	Controls

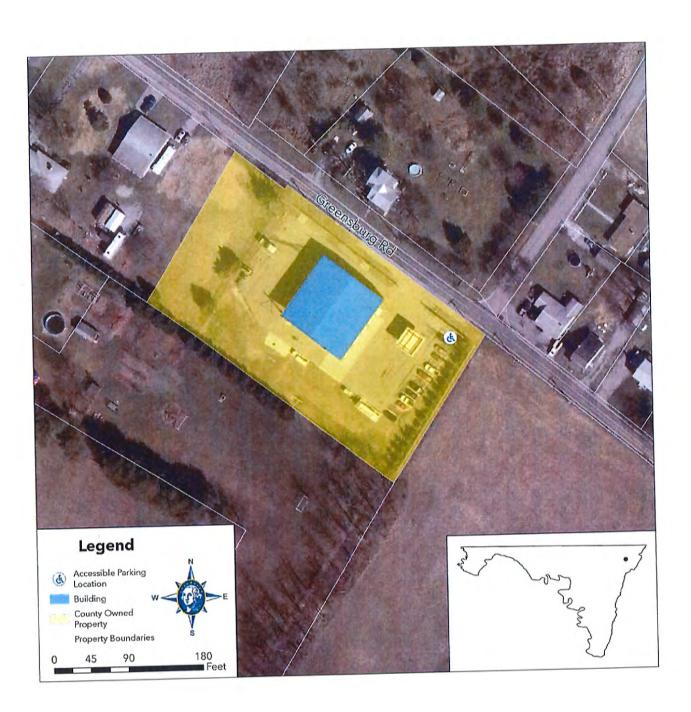
Service Counters
						Drinking Fountain
	Install self closing door hinges on stall door.	604.8.1.2	Stall door is not self-closing.	A-21	91.	Toilet Compartment (Stalls)
	Relocate both side and rear grab bars to compliant locations in reference to water closet. Relocate toilet paper dispenser to compliant location.	504.5.1, 604.5.2, 604.9.6	Grab bar does not extend at least 12" from toilet centerline (6"). Rear grab bar does not extend at least 24" from toilet A-24, A-25 centerline to open side (16"). Toilet paper dispenser is less than 7" from the front of the water closet (0").	A-24, A-25	7M	Water Closets
	Relocate soap dispenser and hand towel dispenser to compliant locations.	606, 606.1	Soap dispenser (52") and towel dispenser (57.5") is higher than 44" above floor over lavatory.	A-25	JE	Soap Dispensers and Hand Dryers
74	Install complaint signage on latch side of door. Wrap/insulate pipes to protect against contact. Relocate coat hook to complaint height.	703, 606.5, 603.4	Sign is not on latch side of door (on door) and does not have A-9, P-6, A raised characters or braille. Pipes are not insulated or configured to protect against contact. Coat hook greater than 48" above floor (60").	A-9, P-6, A 27	7M	Tollet Room - Accessible Route

-	Install signage. Replace door threshold. Adjust door closing speed to at least 5 seconds from 90 to 12 degrees.	216, 404.2.5, 404.2.8	No Signage designating main entrance or accessible entrance. Door threshold higher than .25" (3"). Door closes in less than 5 seconds form 90 to 12 degrees.	A-9, A-1, A- 2	7M	Main Entrance
+						Curb Ramps

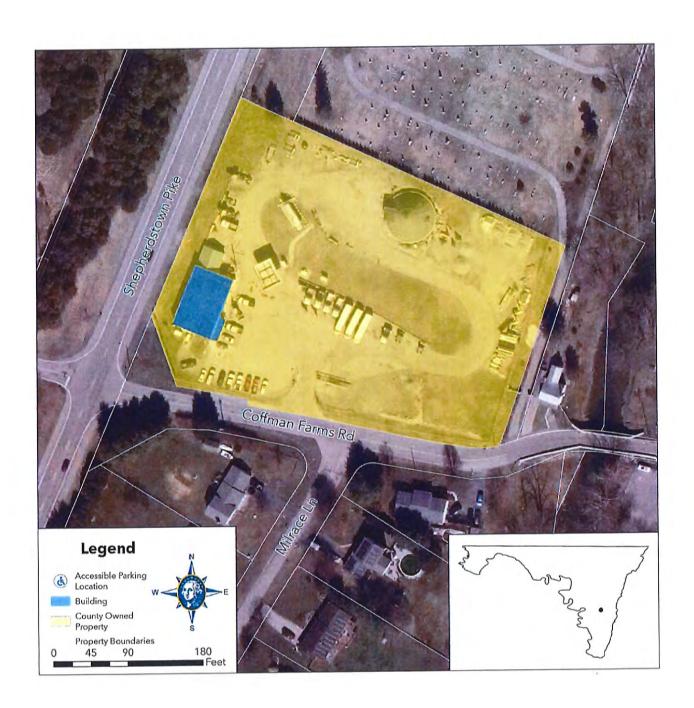
\$25	Relocate soap dispenser and hand towel dispenser to compliant locations.	606, 606.1	Soap dispenser is higher than 44" above floor over lavatory (51"). Hand towel dispenser is located behind sink at an inaccessible location. Hand towel dryer is is out of accessible reach of 48" (49").	A-25	7M	Soap Dispensers and Hand Dryers
\$1,000	Install complaint signage on latch side of door. Install door hardware that doesn't require tight grasping, pinching, or twisting of the wrist. Recommendation: remove stall and make bathroom single-use to allow for lavatory approach OR remove shower and move lavatory to shower location to allow for adequate clearance for toilet room fixture approach. Replace lavatory fixture. Wrap/insulate pipes to protect against contact. Relocate coat hook to complaint height.	216, 404.2.7, 606.2, 606.5, 603.4	Sign is not on latch side of door (on door) and does not have raised characters or braille. Door hardware is not accessible. No clear path at least 36" to toilet room fixtures. Inadeqate clear floor space for lavatory approach. Lavatory fixture is not accessible (not adeqaute clear knee/toe clearance). Pipes are not insulated or configured to protect against contact. Coat hook greater than 48" above floor (65").	A-9, A-22, A-23, P-6, A-27	8	Toilet Room - Accessible Route

Benches
						Seating
						Fire Alarm Systems
						Controls
\$150	Install complaint signs for permanent rooms on latch side of door with braille and raised characters.	216	There are no signs designating permanent rooms throughout the building (Except bathroom which has a noncomplaint sign located on door).	A-9	5M	Signs
						Elevators
						Ramps
\$0	Adjust door closing speed to compliant speed.	404.2.8	Door Closing speed is too fast.	A-2	ZM.	Interior Accessible Route
\$1,250	Install signage. Replace entrance door with wider door. Adjust door closing speed to at least 5 seconds from 90 to 12 degrees.	216, 404.2.3, 404.2.8	No Signage designating main entrance or accessible A-9, A-1, A entrance. Entrance door is not accessible with a width not at least 32" (30"). Closing speed is too fast.	A-9, A-1, / 2	7M	Main Entrance
						Curb Ramps
						Exterior Accessible Route
\$150	Have parking lot painted with space closest to asscessible route deemed as handicap/van accessible with space and asile totalling 16' wide. Have handicap signage installed at space and aisle at compliant height	502	No handicap or van accessible spaces are adequately marked and no signage for handicap spaces is present.	5-2, 5-9	44	Parking

Service Counters	Drinking Fountain	Toilet Compartment (Stalls)	Water Closets
				6M
				A-24, A- 22, A-25
				Centerline of water closet is more than 18" from sidewall (19.5"). Less than 55" of clearance from rear wall (54"). Rear grab bar does not extend adequate distances from water A-24, A-closet centerline. Toilet paper dispenser is less than 7" from 22, A-25 front of water closet (0").
				604.8, 604.5.2, 604.9.6
Total				Relocate both side and rear grab bars to compliant locations in reference to water closet. Relocate toilet paper dispenser to compliant location. Recommendation: remove stall and make bathroom single-use to provide compliant water closet clearance from rear wall.
\$2,600				\$25

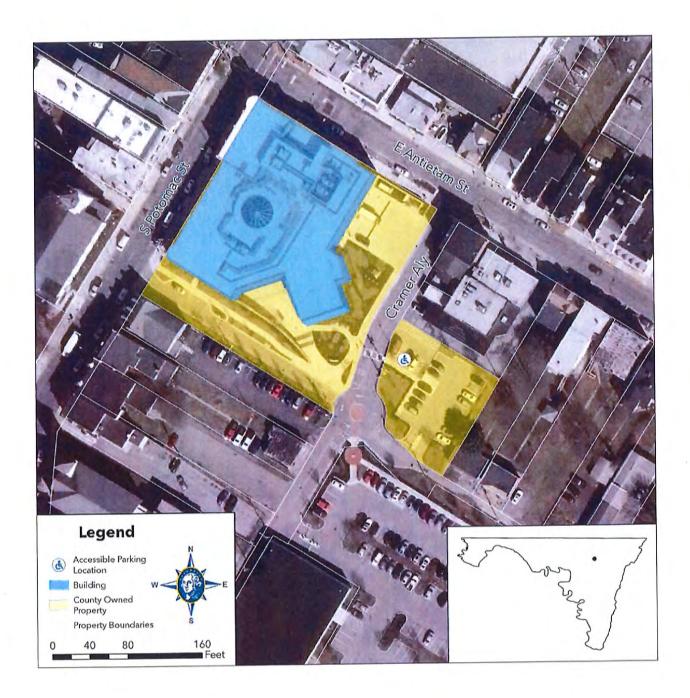
Washington County Free Library

Washington County Government						
Buildings / Facilities						
			Central Library			
			100 S Potomac Street, Hagerstown, MD 21740	21740		
Parking Room / Space	Priority 4H	S-2	Accessionity Denciency Slopes exceed 2.08% at accessible parking location (3.3%).	504.2	Ensure slopes at accessible parking location do not exceed 2.08%.	\$0
Exterior Accessible Route	2н	X	Running slope along route exceeds 5% (9.5%). Cross slope along route exceeds 2.08% (3.7%).	403.3	Ensure that slopes along exterior accessible	*Steep portions of exterior accessible route may be outside county right of way
Curb Ramos					route are within accessible slope compliancy.	(City sidewalks).
or or restriction			Entrance from Potomac Street			
Entrance						
Entrance			Entrance from Parking Lot			
Interior Accessible Route						
Ramps	4	\$	Ramp rise is greater than 6 inches and handrails are not present on either side.	405.8	Install handrails on both sides of ramp.	\$2,125

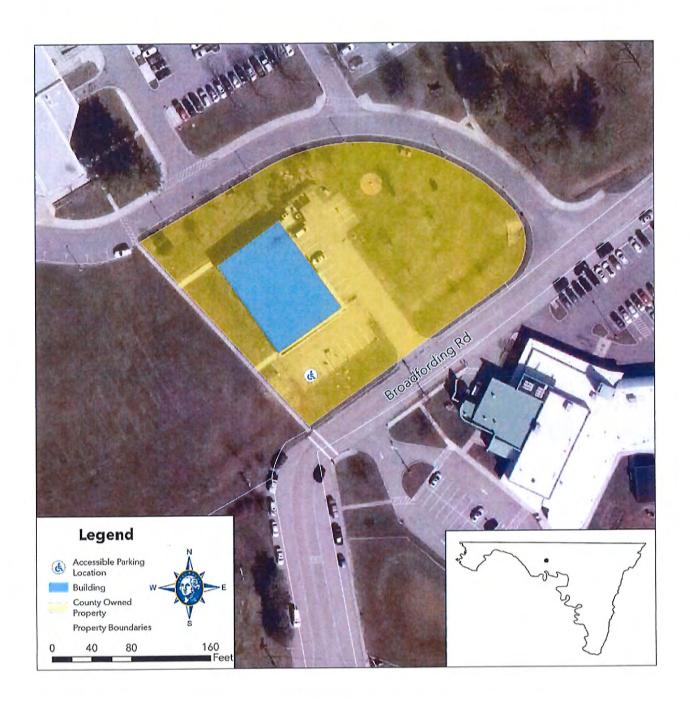
Leonard P. Snyder Memorial Library

ss bathroom and \$250 ant hights. Replace \$250 closer to sidewall. \$500 compliant hights. \$250 closer to sidewall. \$250 closer to sidewall. \$250 closer to compliant \$500 closer to sidewall.	location.					Drinking Fountain
	location.					Drinking Fountain
	location.					Tollet compartment (Stalls)
	Move/Relocate toilets 1" closer to sidewall. Relocate toilet paper dispenser to compliant	604.2, 604.7	Center line of water closet is more than 18" from side wall [(19"). Tollet paper dispenser is less than 7" from the front of the water closet (0").	A-24, A-25	7M	Water Closets
						Soap Dispensers and Hand Dryers
	Relocate bathroom signs to compliant hights. Replace door thresholds.	703.4.1, 404.2.5	Bathroom signs lowest is character is not at least 48" above the floor (45.5"). Door threshold is higher than .25" (.5").	A-9, A-2, A- 27	7M	Toilet Room - Accessible Route
			Women's Toilet Room

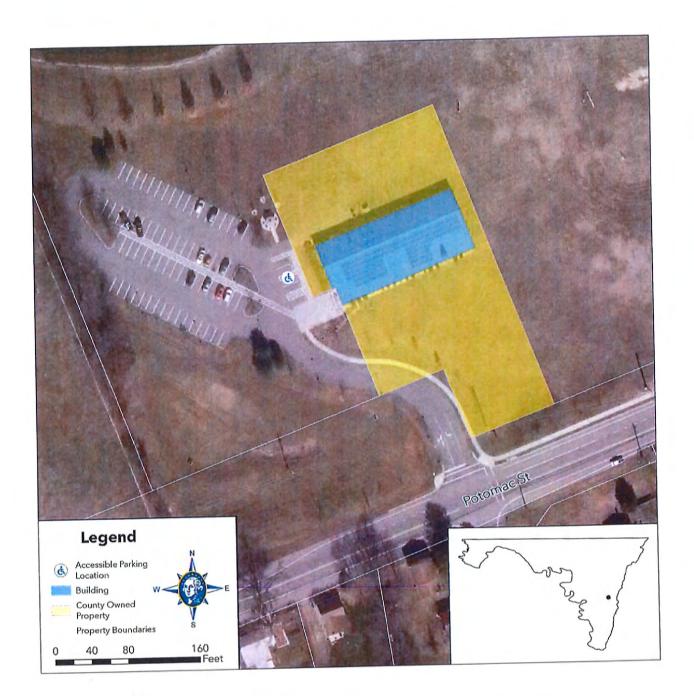
Boonsboro Library

\$10.090	Total					
	c					Service Counters
\$0	Relocate plant to location where it does not interfere with clear floor space / approach to drinking fountain.	602.2	Plant does not allow compliant dear floor space for approach to drinking fountain.	4	101	Drinking Fountain
\$70	Install door pulls on both side of stall door that are operable with one hand and do not require tight grasping, pinching or twisting of the wrist. Reorient door so that it swings out, ensure door hardware is self-closing	604.8.1.1, 604.8.1.2	With stall door swinging in, 59" minimum length beyond water closet is not meet(54").	A-20, A-24	7M	Toilet Compartment (Stalls)
						Water Closets
\$0	Relocate coat hook to location within 48" above floor.	603.4	Coat hook is located higher than 48" above floor (54").	A-27	9L	Toilet Room - Accessible Route
			Women's Toilet Room			
\$20	Install door pulls on both side of stall door that are operable with one hand and do not require tight grasping, pinching or twisting of the wrist.	604.8.1.2	There are no door pulls located on either side of the stall door.	A-20	91	Toilet Compartment (Stalls)

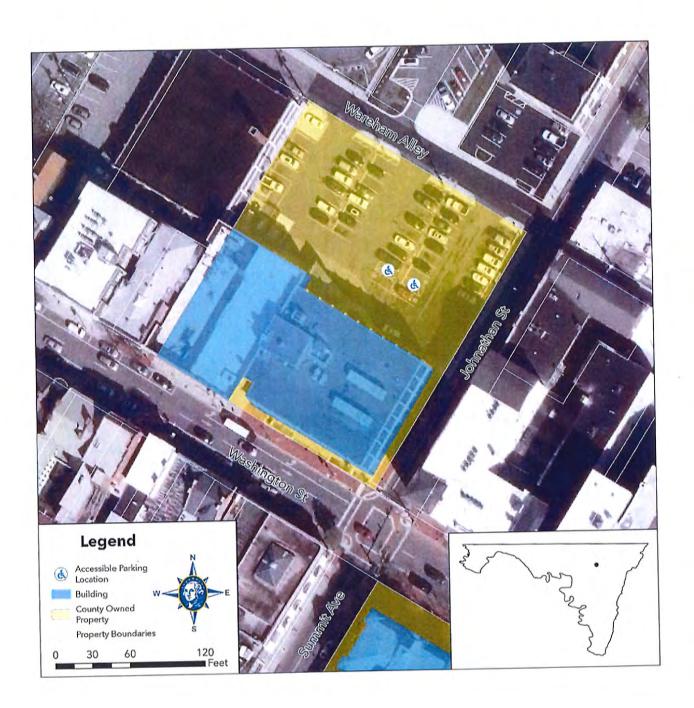
Washington County Government Accessibility Assessment Buildings / Facilities					
			Washington County Administration Building		
			100 West Washington Street, Hagerstown, MD 21740	0	
Room / Space	Priority	Key Note	Accessibility Deficiency Accessibility Deficiency	ADA Code Reference	Recommendation Level out ground surface to slope that is in
Parking	4H	\$-2, \$-9	Slope at current location of accessible parking space is higher than 2.08% (2.3%). Signage is not at a minimum height of 60" (55"). No signage designating space as van accessible.	502.3.3, 502.4, 502.6	compliant range. Repost signage designating "van accessible" parking space and discouraging parking in access aisle at compliant height.
Exterior Accessible Route					
Outh Pamps					
Curb Ramps			Entrance from Parking Lot		
Main Entrance	6M	5-9, A-9, A-11	Inaccessible entrances do not have signs indicating the nearest accessible entrances. Accessible entrances do not have signs with the international Symbol of Accessibility. Door threshold is too high (.75°).	216.6, 404.2.5	Install signage at in-accessible entrances indicating the nearest accessible entrances and at accessible entrances with the International Symbol of Accessibility. Replace Door threshold.
