# *Lead Inspection Report*

**14616 Pennsylvania Avenue  
Hagerstown, MD**

Date of Inspection:  
**12/1/2022**

**RE: *Limited Lead-Based Paint Risk Assessment  
14616 Pennsylvania Ave., Hagerstown, MD.***

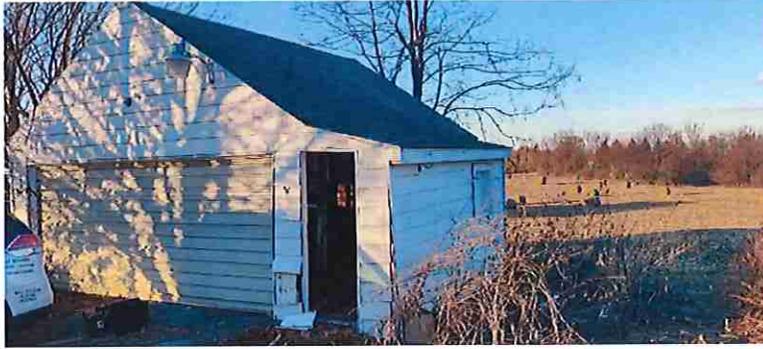
- The person door
- The window components

Garage People Door and Window Components

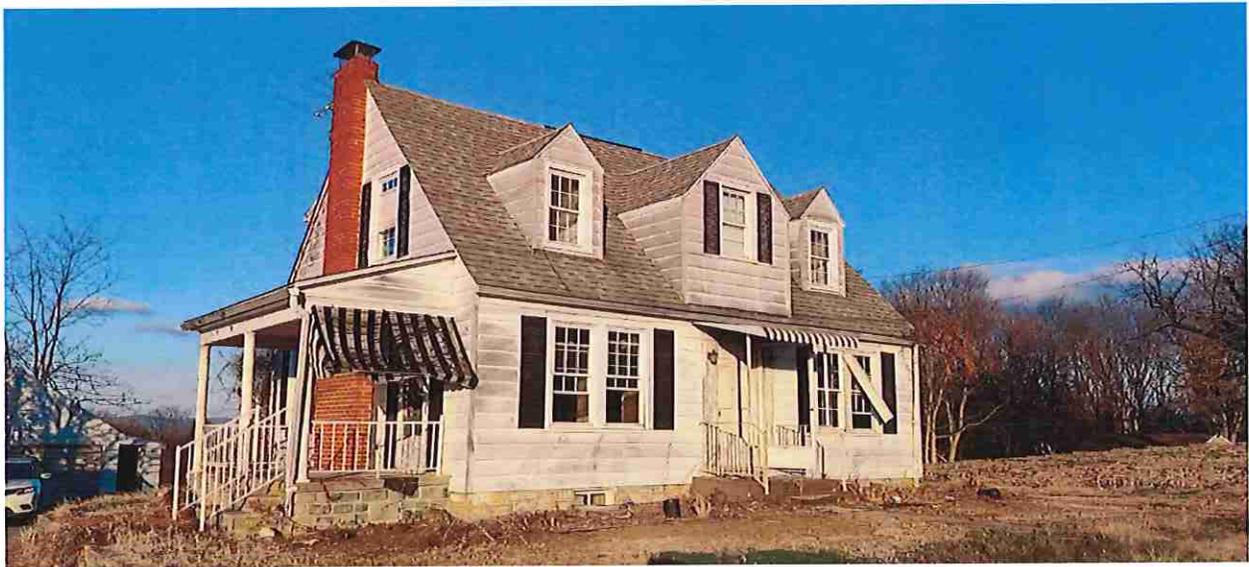
Wooden Door Components

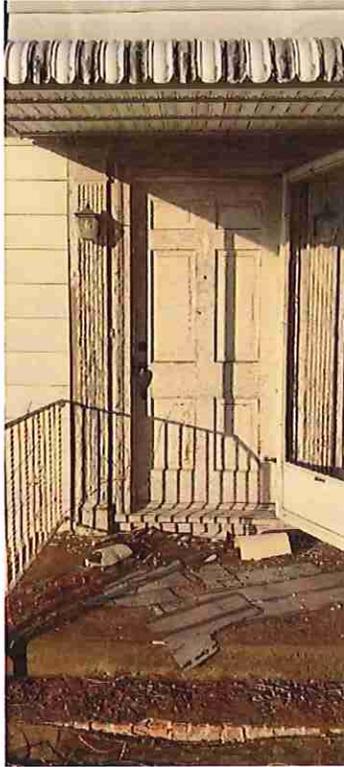
Wood Door Components

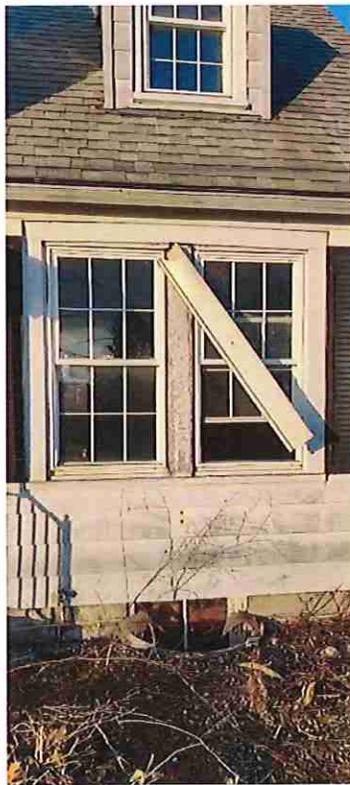
Wood Window Components, possibly under wrap

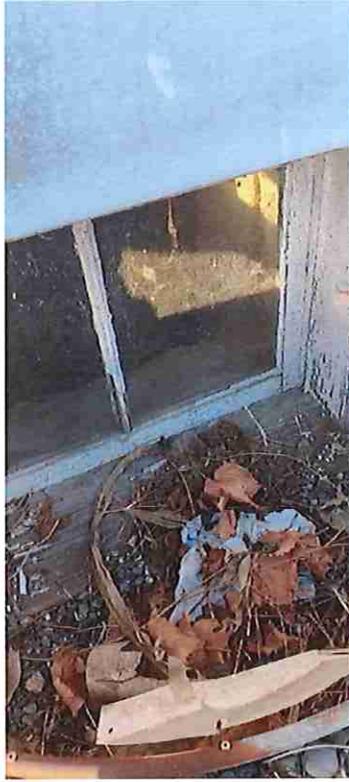
Wood Basement Window Components

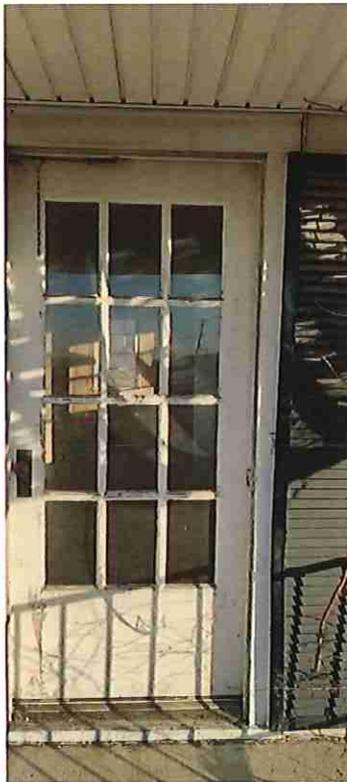
Wood Door Components

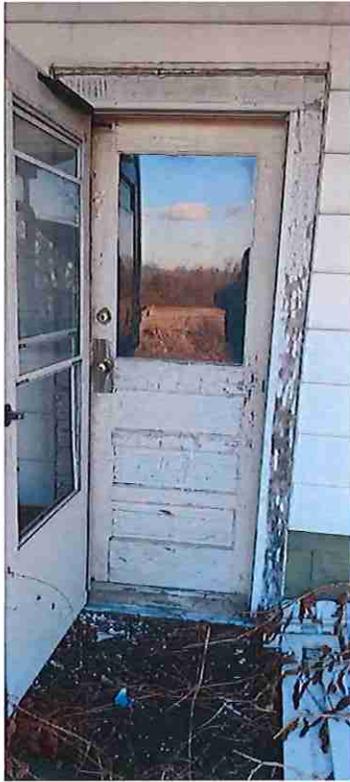
Wood Door Components

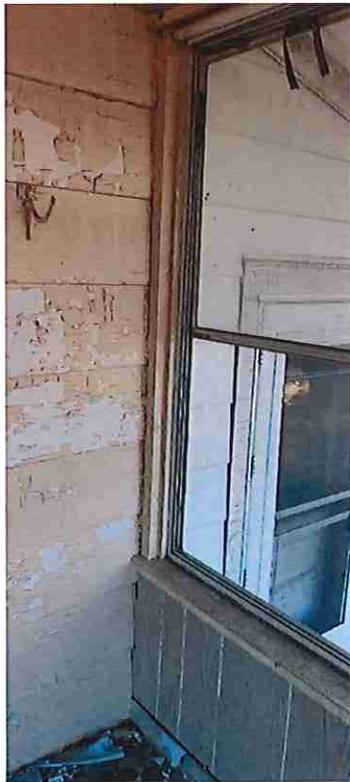
Wood Siding, possibly under wrap as well

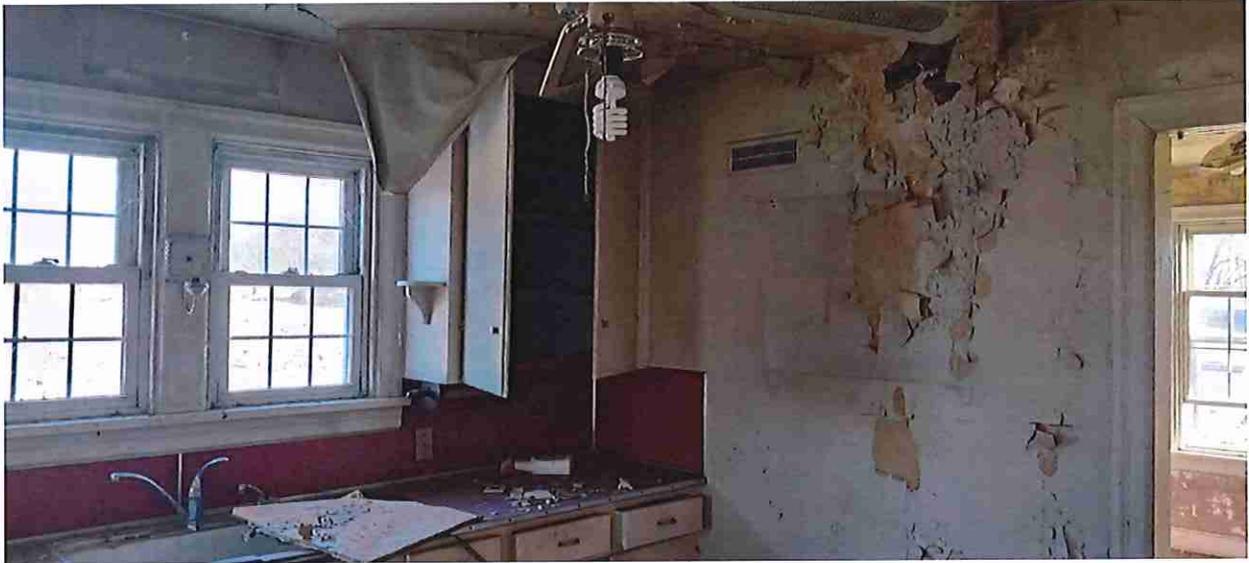
Kitchen Wall A

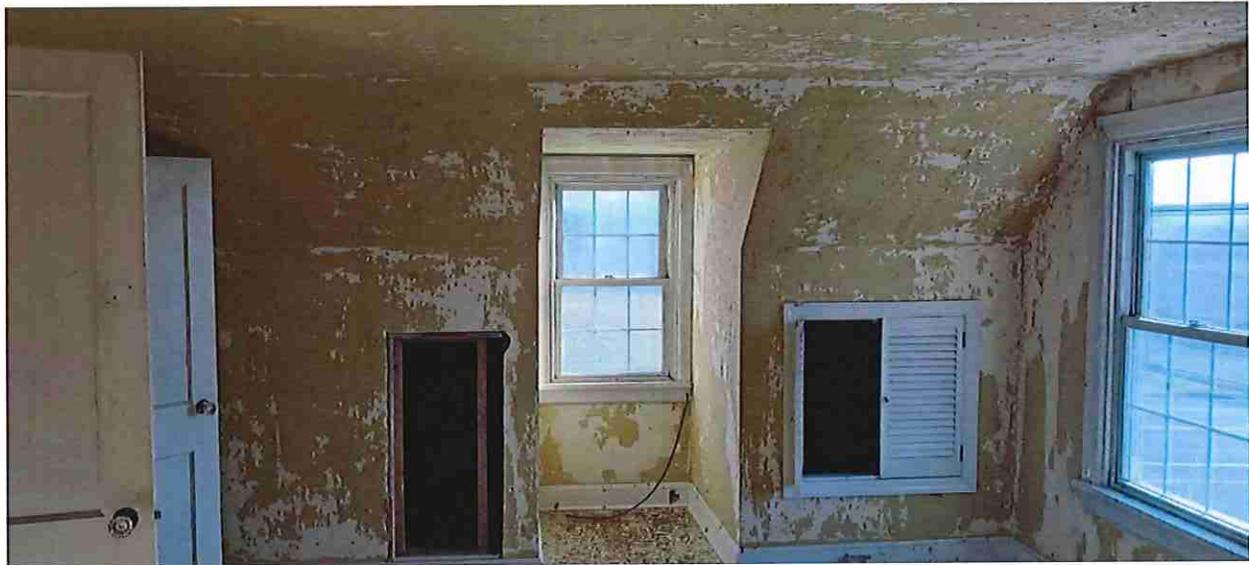
Bedroom 2 Walls

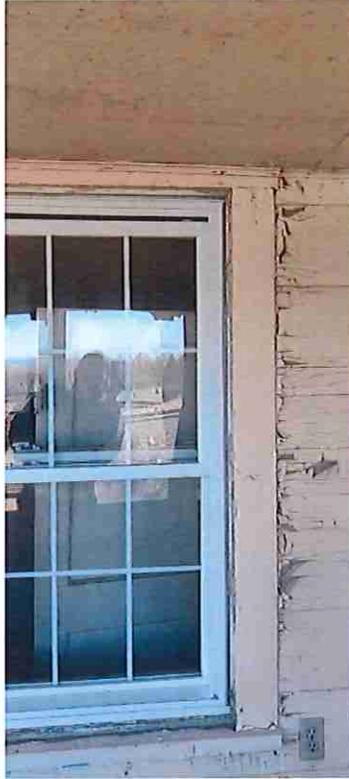
Back Porch Wood Window Components, Wall Side and Ceiling
