HISTORIC DISTRICT COMMISSION OF WASHINGTON COUNTY, MARYLAND

1. **HTC-25-001, 32 E Baltimore Street, Funkstown - WA-I-639 - (Discussion/Comments) -**
Part 1 and Part 2 application for tax credits at the Keller House*

Application for Historic Properties Tax Credit

Part II – Description of Rehabilitation

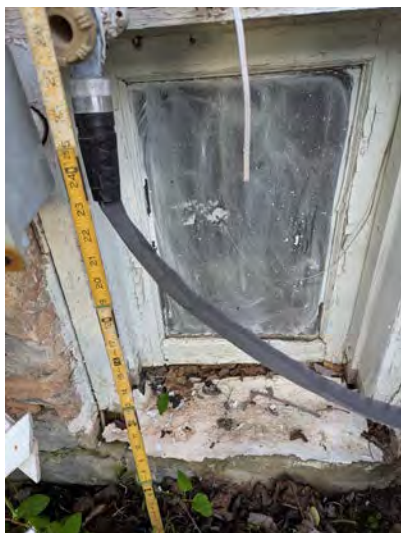
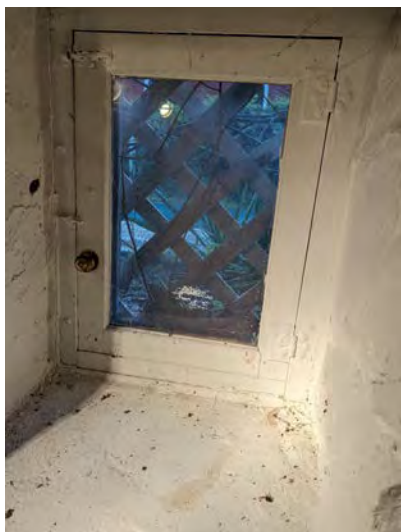
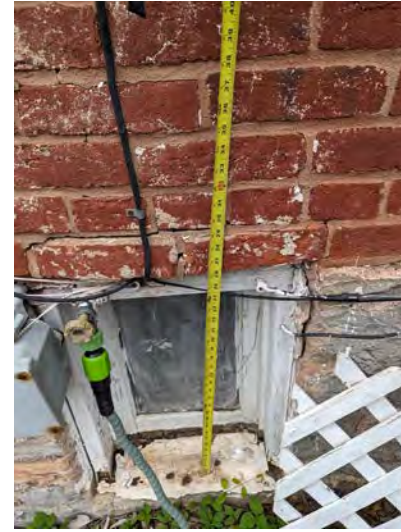
BASEMENT WINDOWS 1

BASEMENT WINDOWS 3

BASEMENT WINDOWS 10

Number	Feature
	REPLACE MAIN HOUSE BASEMENT WINDOWS
<p>Describe existing feature and its condition There are three existing basement windows 18x24" in the stone foundation on the west side of the main house. The sills and surrounding frame are rotting due to the fact that the previous owner raised the ground level after building a stone retaining wall adjacent to the pool.</p> <p>Describe work and impact on feature There are two options. #1 to build window wells with clear plastic cover to keep out water. #2 Raise the bottom level of each window 6-8" by replicating the stonework and repairing and/or replacing the wood frame. #2 is the preferred option to retain the character of the windows.</p> <p>Photo Numbers BASEMENT WINDOWS 1-11 Drawing Numbers</p>

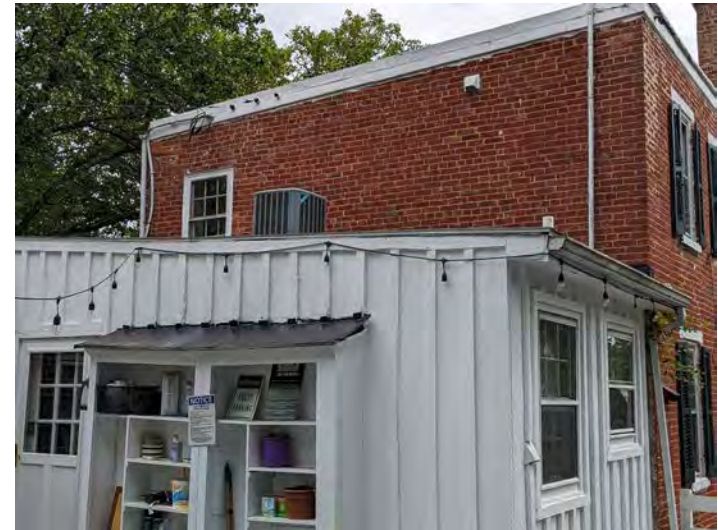
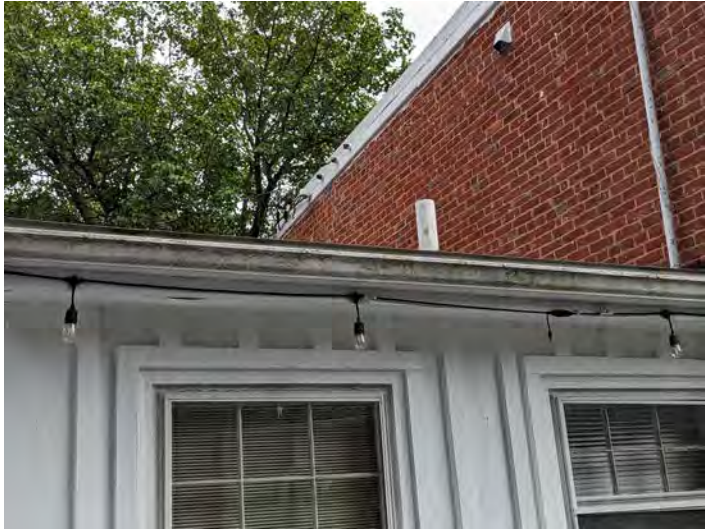
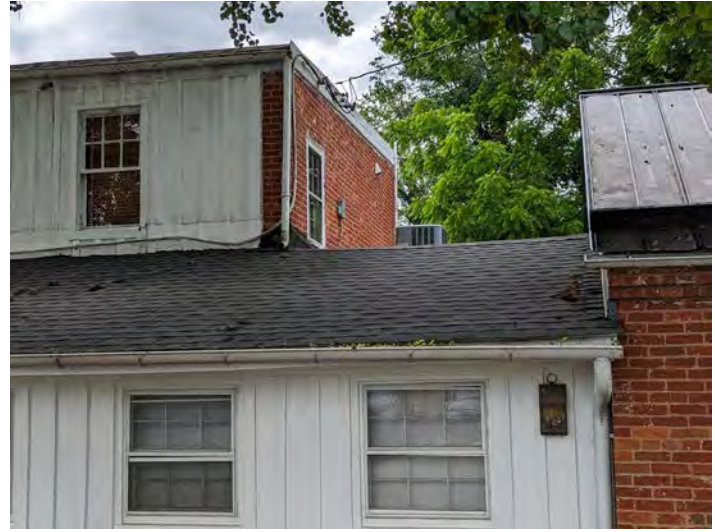
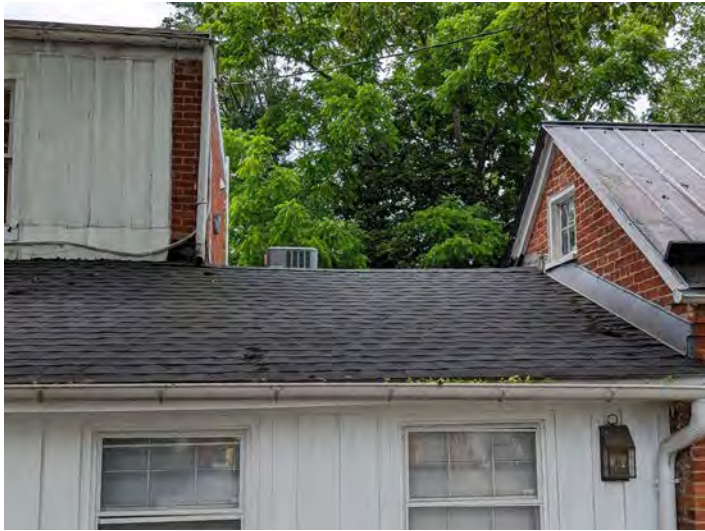
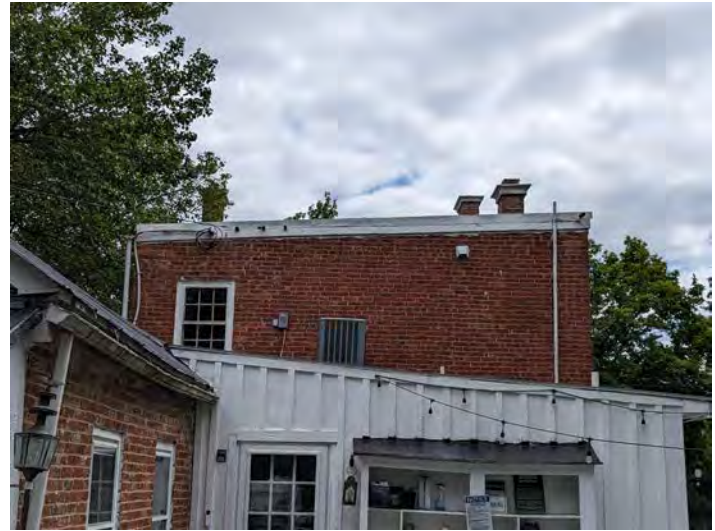
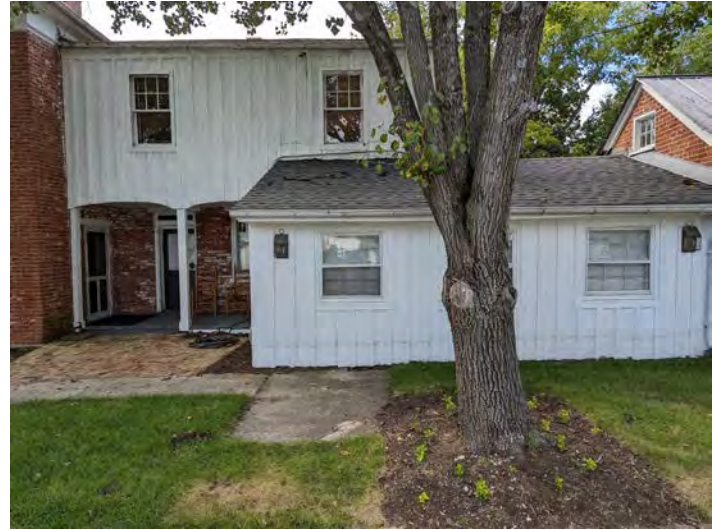
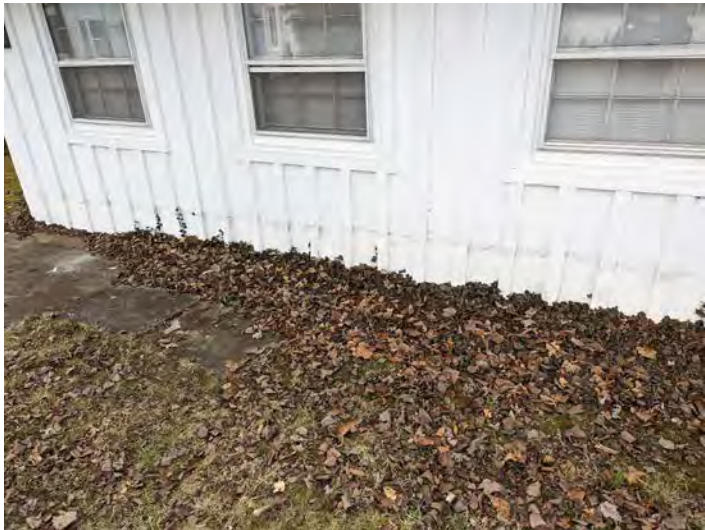
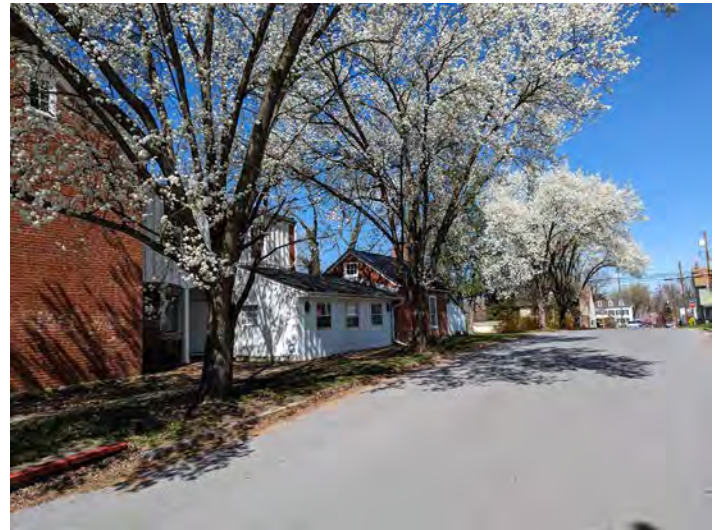
BOARD AND BATTEN ADDITION 1

BOARD AND BATTEN ADDITION 2

BOARD AND BATTEN ADDITION 3

BOARD AND BATTEN ADDITION 4

BOARD AND BATTEN ADDITION 5

BOARD AND BATTEN ADDITION 7

BOARD AND BATTEN ADDITION 8

BOARD AND BATTEN ADDITION 9

Number	Feature
	REPLACE FRAME CONNECTING STRUCTURE
<p>Describe existing feature and its condition</p> <p>A section connecting the house and summer kitchen was built in the 1970s. It was poorly insulated and partly built on an existing concrete slab (not to code) and directly on the ground (no slab). Sections of board and batten siding have rotted and some replaced with aluminum. Windows are small and inappropriate for the house. The roof line adjacent to High Street is low and a hazard to pedestrians. Part of the roof intersects awkwardly & interferes with the summer kitchen roof line.</p> <p>Describe work and impact on feature</p> <p>Preliminary plans for a new connector/sitting room have been drawn up. The replacement has a slightly smaller footprint and is designed to separate/accentuate the summer kitchen. Plans by architect William Wheeler who has worked on many notable older properties, from Kalorama and Embassy Row to Merrywood and Marwood on the Potomac.</p> <p>Photo Numbers BOARD AND BATTEN ADDITION 1-9 Drawing Numbers BOARD AND BATTEN REPLACEMENT A002-A004</p>

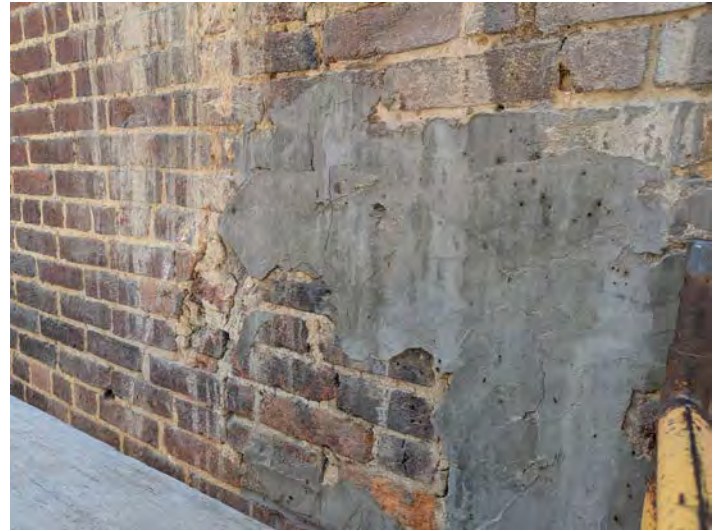
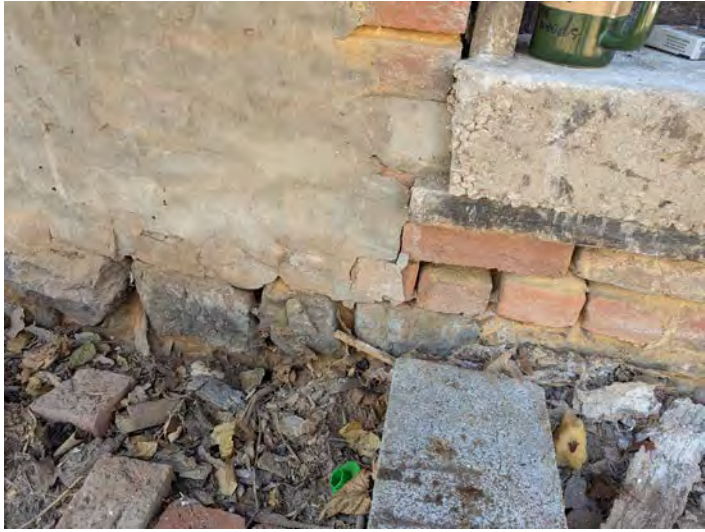
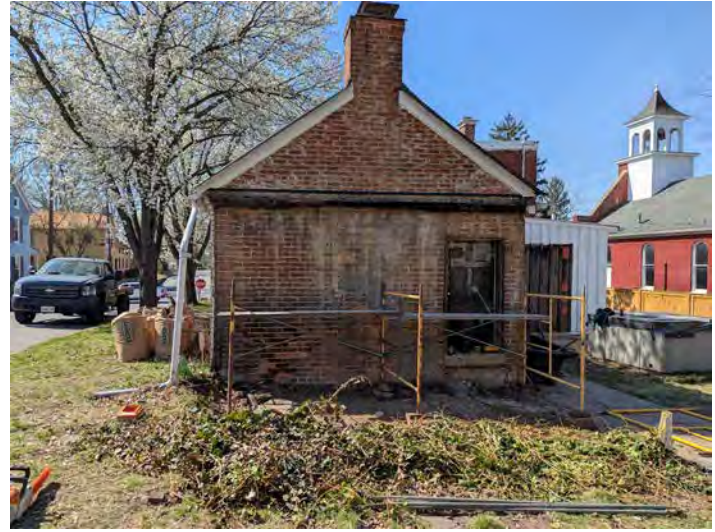
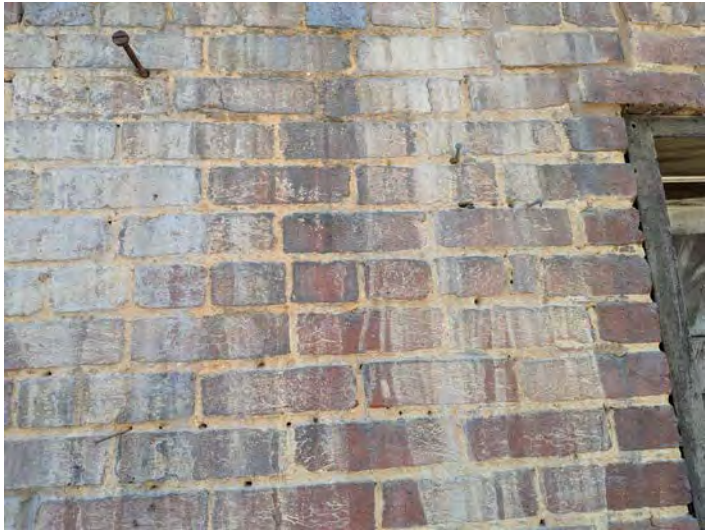
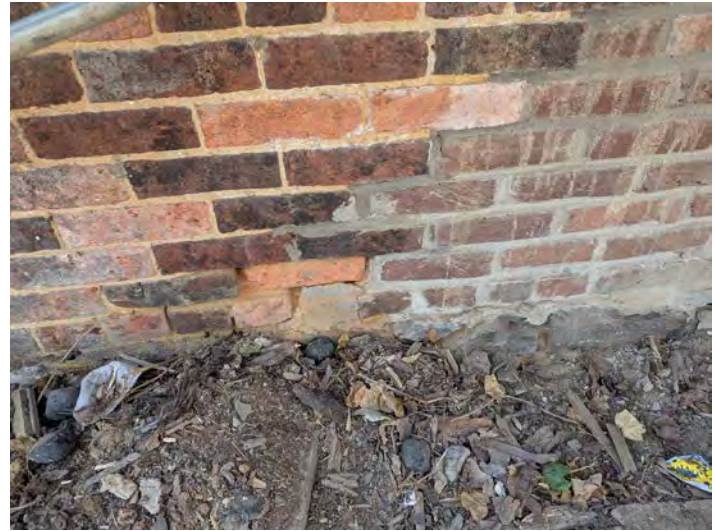
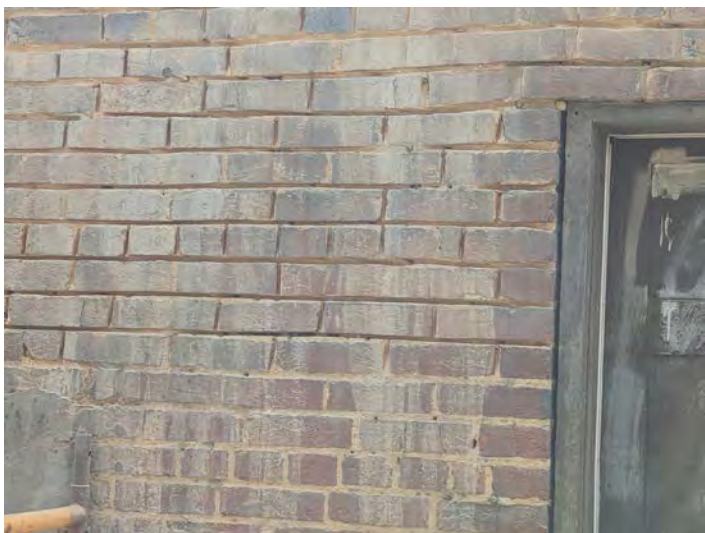
SUMMER KITCHEN NORTH WALL BRICK 1

SUMMER KITCHEN NORTH WALL BRICK 2

SUMMER KITCHEN NORTH WALL BRICK 3

SUMMER KITCHEN NORTH WALL BRICK 4

SUMMER KITCHEN NORTH WALL BRICK 5

SUMMER KITCHEN NORTH WALL BRICK 6

Number	Feature	SUMMER KITCHEN MASONRY REPAIRS
<p>Describe existing feature and its condition brick and stonework mortar was missing/deteriorated and some brick was covered by Portland cement that had deteriorated the brick</p>		
<p>Describe work and impact on feature Remove a 20th century shed structure on the north end. Rebuild the north wall (below the gable). 1/4 to 1/3 of the original north wall brick was deteriorated. A large area had been parged with Portland cement and that brick was damaged. Replace and repoint to match existing brick and mortar. Repoint two courses of brick at the base of the west wall that had been covered by the wood deck. Repoint stone foundation on north and west sides.</p>		
<p>Photo Numbers</p>		<p>Drawing Numbers</p>
<p>SUMMER KITCHEN NORTH WALL BRICK 1-26</p>

Number	Feature	SUMMER KITCHEN MASONRY REPAIRS
<p>Describe existing feature and its condition Uncover masonry that had, at one time, been covered when adjacent High Street was built or raised.</p>		
<p>Describe work and impact on feature At some time the High Street ground was raised, covering the east and north stone foundation as well as some brickwork. A low retaining wall (matching the stone foundation) along High Street/adjacent to the north end of the summer kitchen will uncover more of the north wall stonework and hold back water from the street.</p>		
<p>Photo Numbers</p>		<p>Drawing Numbers</p>
<p>SUMMER KITCHEN NORTH WALL BRICK 1-26</p>

Tore down old wooden shed against North wall. Mortar was deteriorating. Some brick was parge-coated with concrete. Cleaned out old mortar and rebuilt wall where needed. Brick was cleaned up from old paving on site to match wall. Santan mortar was used to match existing mortar that was already repointed. repointed where needed. pd. \$5400.-

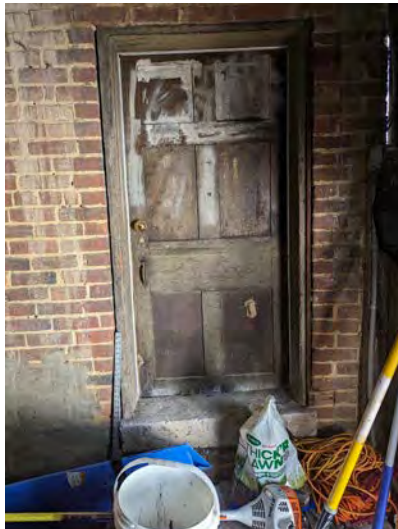
SUMMER KITCHEN NORTH WALL DOOR 1

Number	Feature
	SUMMER KITCHEN WINDOW AND DOOR REPAIRS
<p>Describe existing feature and its condition Restore summer kitchen windows and doors</p>	
<p>Describe work and impact on feature Restore four 6/6 windows on east and west sides and south gable attic window. Replace four metal storm windows with appropriate windows. Restore the original summer kitchen exterior door, frame and threshold, all of which is in great shape considering age. Due to the 20th century addition of a brick floor in the summer kitchen, about 2" of the bottom of the door was removed but the threshold is at the same level. This requires raising the threshold by adding one course of brick and raising the threshold. Build appropriate wood steps and landing to the summer kitchen door.</p>	
<p>Photo Numbers</p>	<p>Drawing Numbers</p>
SUMMER KITCHEN NORTH WALL DOOR 1-6

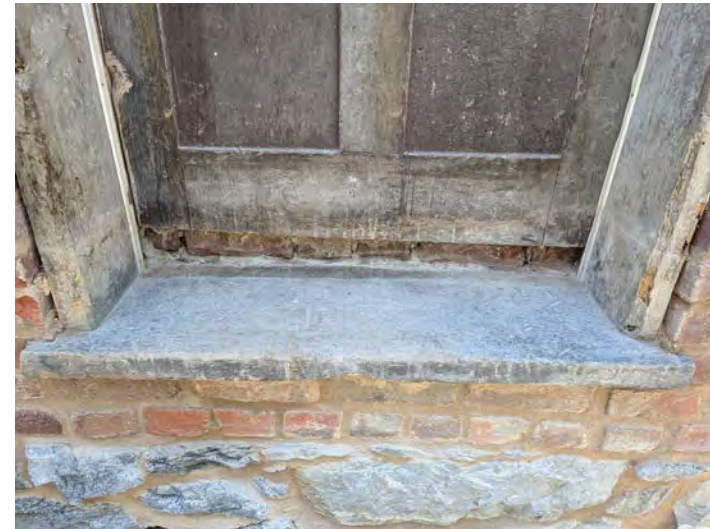
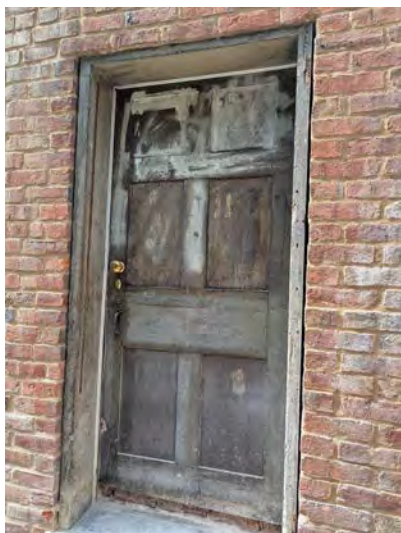
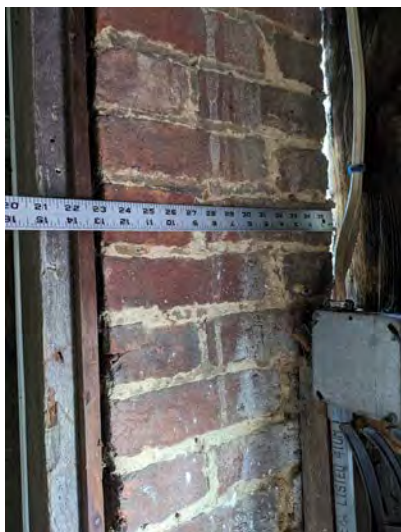
SUMMER KITCHEN NORTH WALL DOOR 2

SUMMER KITCHEN NORTH
WALL DOOR 3

SUMMER KITCHEN NORTH
WALL DOOR 5

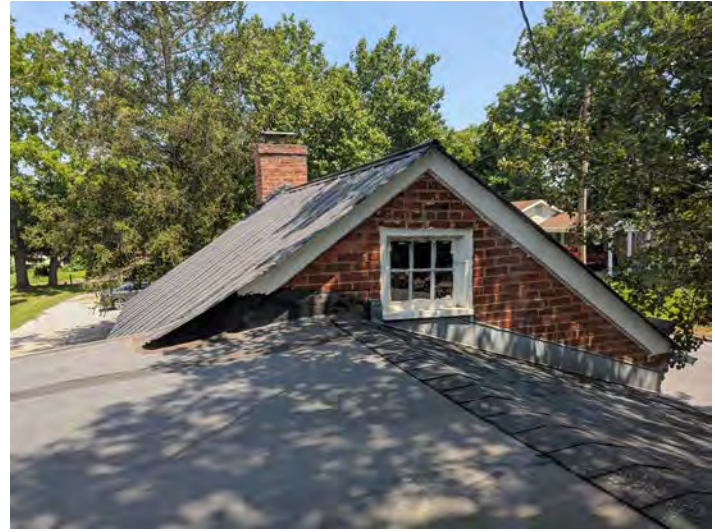
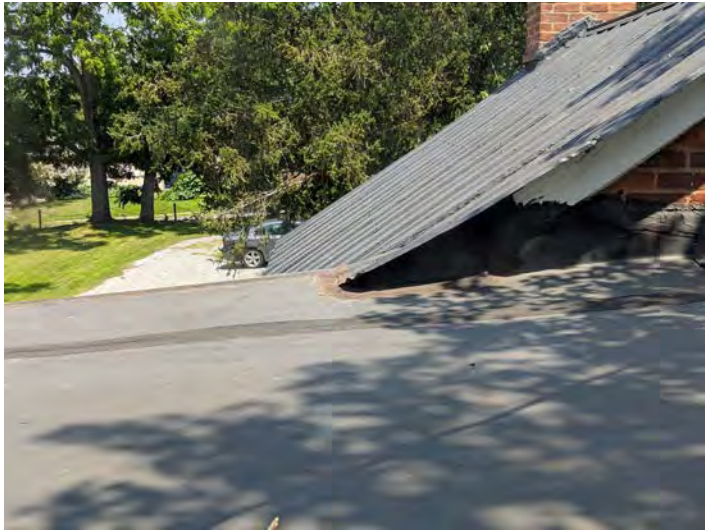
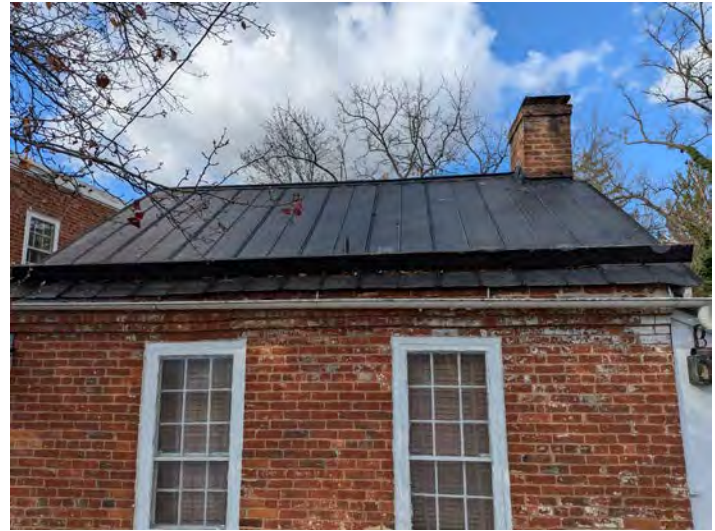
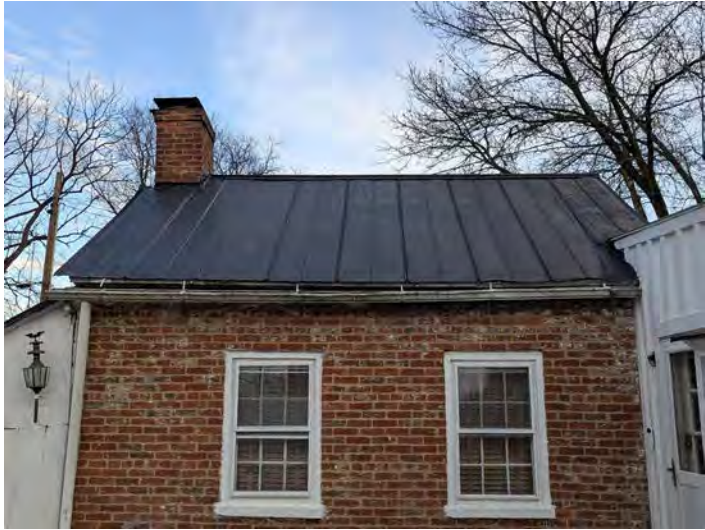
SUMMER KITCHEN ROOF 1

SUMMER KITCHEN ROOF 2

SUMMER KITCHEN ROOF 3

SUMMER KITCHEN ROOF 4

Number	Feature
	SUMMER KITCHEN ROOF REPAIR/REPLACEMENT
<p>Describe existing feature and its condition Current metal roof is rusted in spots and likely close to it's expected lifespan. In addition, one corner has been compromised by addition of another connecting roof structure.</p>	
<p>Describe work and impact on feature The insurance company required that the metal summer kitchen roof be repaired. Fewer than two dozen small (2") rust areas were discovered but the roof is solid. Wire brush to remove rust and paint with matching black Rustoleum. The eventual goal is to replace the entire roof and restore the southwest corner. Replace aluminum gutters with appropriate galvanized gutters and downspouts.</p>	
<p>Photo Numbers</p>	<p>Drawing Numbers</p>
SUMMER KITCHEN ROOF 1-4

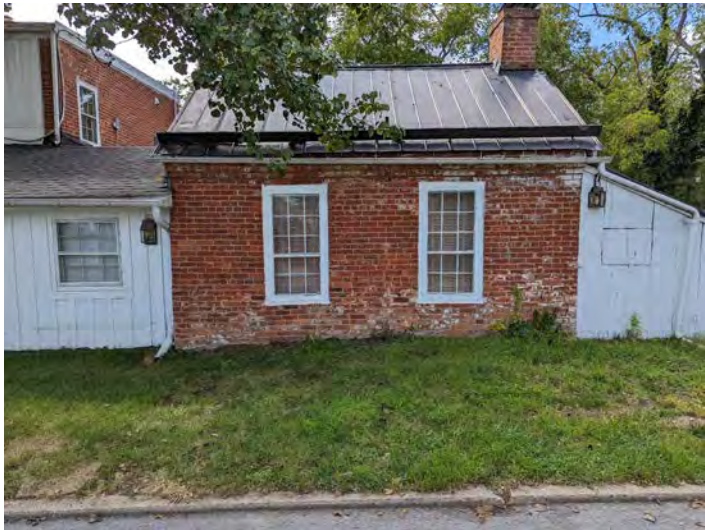
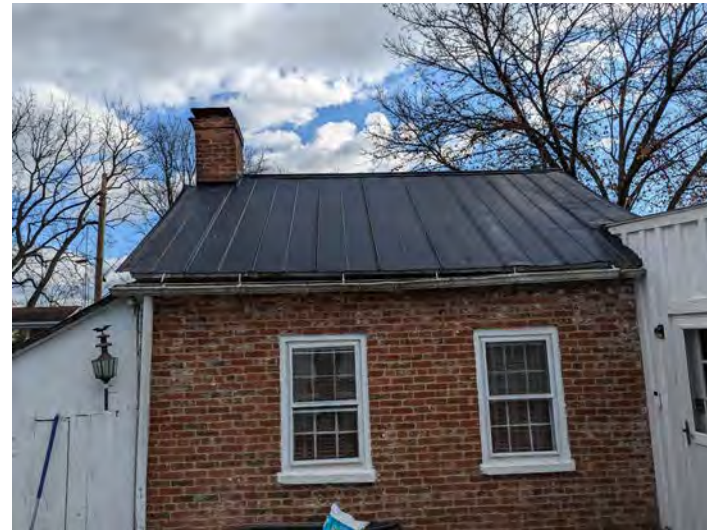
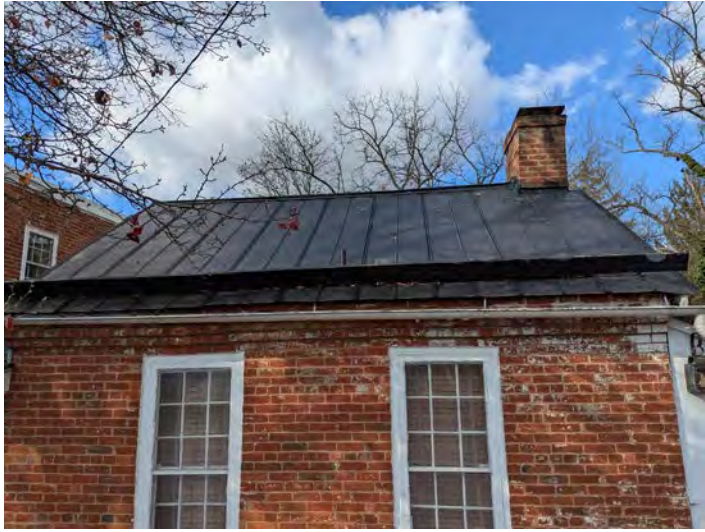
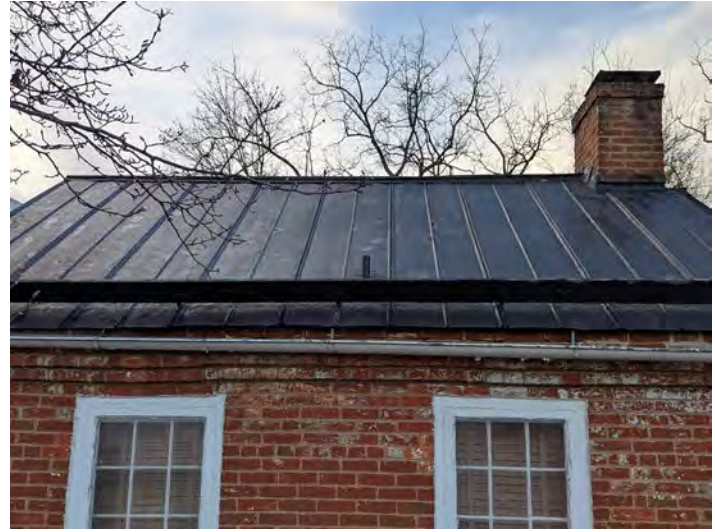
SUMMER KITCHEN WINDOWS 1

SUMMER KITCHEN WINDOWS 2

SUMMER KITCHEN WINDOWS 3

SUMMER KITCHEN WINDOWS 5

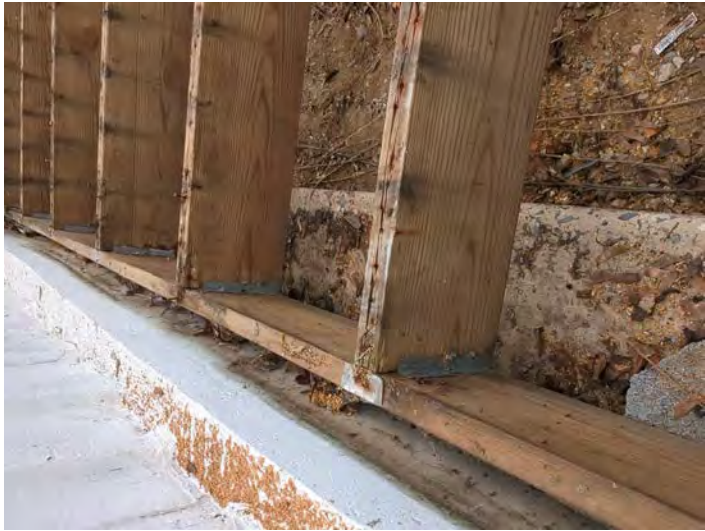
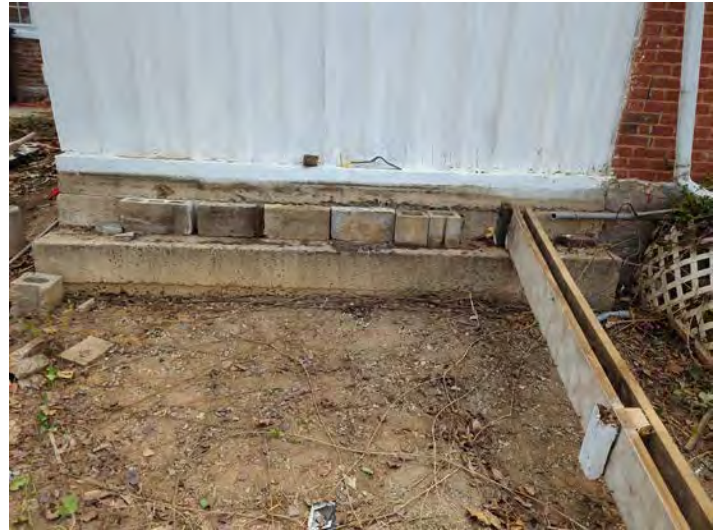
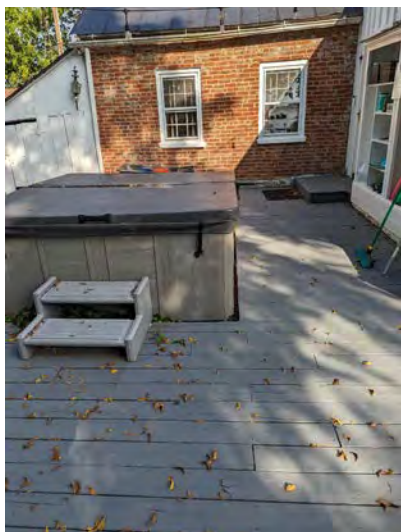
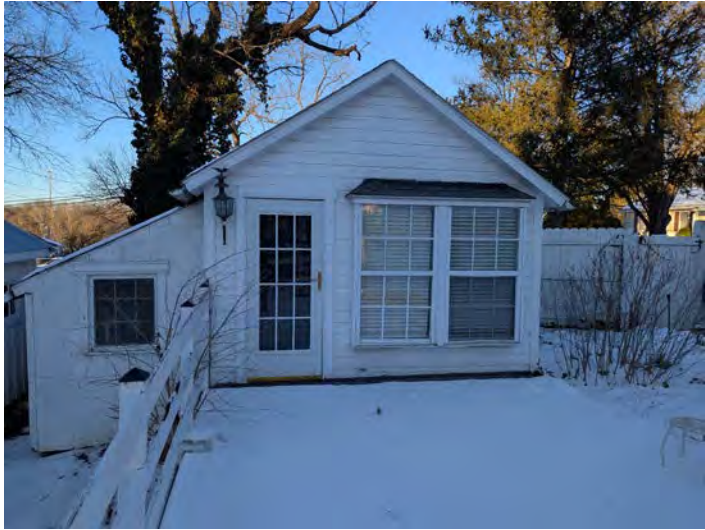
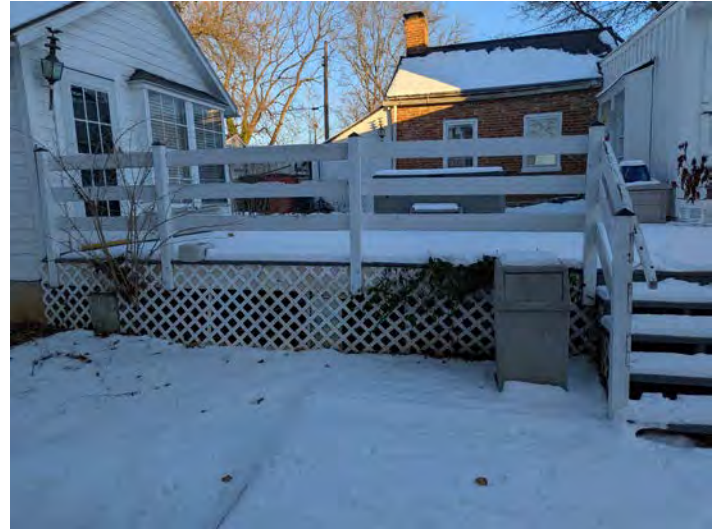
WOOD DECK AND STONE WALLS 1

WOOD DECK AND STONE WALLS 2

WOOD DECK AND STONE
WALLS 3

WOOD DECK AND STONE
WALLS 5

WOOD DECK AND STONE WALLS 7

WOOD DECK AND STONE WALLS 8

Number	Feature
	WOOD DECK REPLACEMENT & RETAINING WALLS
<p>Describe existing feature and its condition The existing deck was probably installed in the 1980s or 90s. Joists, deck and railing had deteriorated to the extent that the deck was unsafe and needed to be replaced.</p> <p>Describe work and impact on feature Removed deck due to deterioration of joists, deck boards and railings. Built new retaining wall to replace the 36-40" slope below the deck. Use barn stone from dismantled Sharpsburg Pike barn to match the house & summer kitchen stone foundations. Smaller terrace using patio pavers that match the stone foundation</p> <p>Photo Numbers WOOD DECK AND STONE WALLS 1-12 Drawing Numbers</p>
