WASHINGTON COUNTY, MARYLAND ADA SELF EVALUATION BUILDINGS, FACILITIES, AND PARKS 2023 UPDATE

Washington County performed a Self-Evaluation of County owned buildings, parks, and facilities.

The initial Self-Evaluation has been updated with new data collected for this update. The results of the survey were used to develop a Transition Plan to address all non-compliant facilities identified.

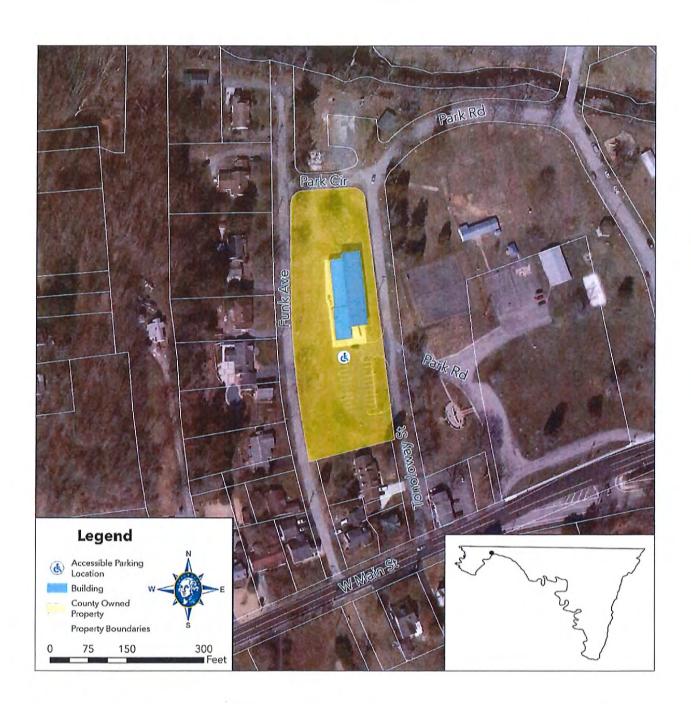
Service Counters	Drinking Fountain	Toilet Compartment (Stalls)	Water Closets	Soap Dispensers and Hand Dryers	Toilet Room - Accessible Route	Benches	Seating	Fire Alarm Systems	Controls	Signs	Elevators	Ramps	Interior Accessible Route	Main Entrance	Curb Ramps	Exterior Accessible Route	Parking	Room / Space			Buildings / Facilities	Accessibility Assessment	Washington County Government
	7M													7M	7M				Priority					
	A-14													A-2	A-2				Key Note					
	Less than 27" of clearance from floor to bottom of counter (26").													Door Closing speed is too fast.	Door Closing speed is too fast.				Accessibility Deficiency	231 Veterans Memorial Parkway, Hancock, MD 21750	Hancock Library

306.3.1													404.2.8	404.2.8				ADA Code Reference	, MD 21750				
Total														Adjust door closing speed to compliant speed.	Adjust door closing speed to at least 5 seconds from 90 to 12 degrees.				Recommendation					
\$0														\$0	\$0				Cost

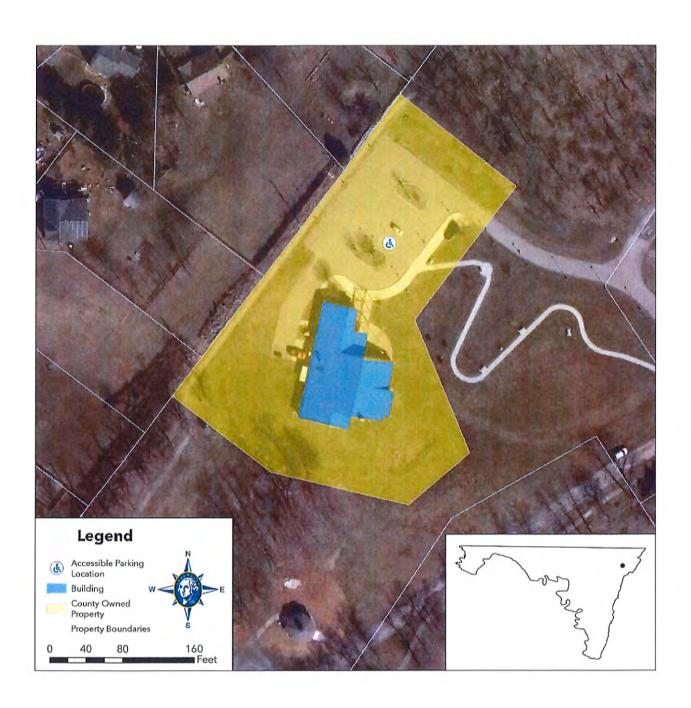
\$1 600	Total				Control of the Contro	
	850					Service Counters
						Drinking Fountain
\$0	Reorient hinges on stall door (currently installed backwards so door is self-opening).	604.8.1.2	Stall door is not self-closing.	A-21	92	Toilet Compartment (Stalls)
						Water Closets
						Soap Dispensers and Hand Dryers
\$0	Lower mirror to where bottom edge at 40" or lower.	603.3	Bottom edge of the mirror (above lavatory) is higher than 40" (40.5").	A-28	JE	Toilet Room - Accessible Route
			Women's Toilet Room			
						Toilet Compartment (Stalls)
\$0	Relocate grab bars to compliant locations.	604.5.2	Rear wall grab bar extends less than 12" towards side wall past water closet centerline (10.5").	A-24	JL	Water Closets
						Soap Dispensers and Hand Dryers
\$0	Lower mirror to where bottom edge at 40" or lower.	603.3	Bottom edge of the mirror (above lavatory) is higher than 40° (41.5°).	A-28	JL	Toilet Room - Accessible Route

Men's Toilet Room			
						Benches
						Seating
						Fire Alarm Systems
						Controls
						Signs
						Elevators
						Ramps
						Interior Accessible Route
						Main Entrance
\$1,500	Lay a flat landing at top curb ramp with compliant demensions.	406.4	No level landing at top of curb ramp (steeper than 2.08% (2.6%)).	S-7	6M	Curb Ramps
						Exterior Accessible Route
\$100	Ensure surface at compliant level when repaved. Install compliant signage to discourage parking in access aisless.	502.4, 502.7	Cross Slope at access aisle is steeper than 2.08% (4.0%). Access aisles are not marked as to discourage parking in them.	5-3, 5-9	4н	Parking
Cost	Recommendation	ADA Code Reference	Accessibility Deficiency	Key Note	Priority	Room / Space
			to West Water Street, Smithsourg, MD 41/83			
			Smithsburg Library

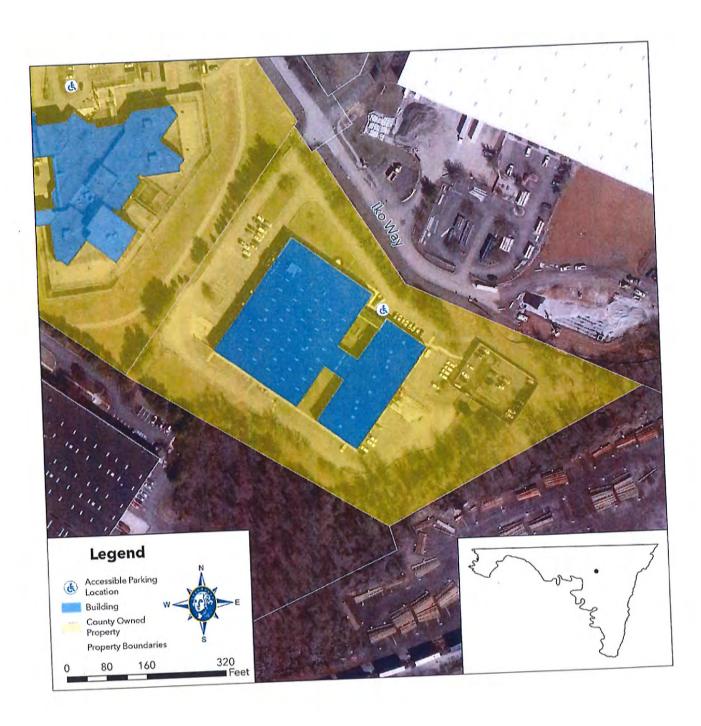
Sign designating toilet room does not have raised characters	<u>.</u>	characters and braille. Remove division wall	
oilet Room - Accessible Route	Wg	A-9, A-22, A-28, A- 27	and does not have trainer. Document accessible pathway to toillet maximum (.5"). There is not accessible pathway to toillet room fixtures it at least 36" wide (35.5"). Mirror height come fixtures outner) is higher than the 40" maximum (47.5"). Cost hook height is higher than the 48" maximum (66").	703, 404,2.5, 206 (Ch t 4,3.3), 603.3, 603.4 t	near entrance to allow for accession of the took toolet fixture. Relocate mirror and coat hook to compliant heights.	\$700
	ā	A-24	Operable parts of soap dispenser are higher than the 44" maximum height [54"). Operable parts of hand towel in some real higher than the 49" maximum height [51").	606, 606.1	Relocate soap dispenser and hand towel dispenser to compliant locations.	OS .

oap Dispensers and Hand Dryers	4		uispeissel un merren and eide (37.5") wall grab bars are mounted		Relocate grab bars to be mounted at	
Water Closets	MT	A-24, P-5	2 %	609.4, 609.3, 604.5, 604.6	reference to water closer. Reforate tollet reference to water closer. Reforate tollet paper dispenser if still protuding with in 12" above side grab bar after grab bar relocation. Replace or reorient plumbling of water closet so that the flusher is on the open side of the water closet.	\$225
			In a stand for our section of the stand		Install self-closing door hinges on stall door.	1
foilet Compartment (Stalls)	16	A-21	Stall door is not self-closing, I there are not upon pairs both side of stall door (only outside). Lock hardware removed from door (for drug testing onsite).	604.8.1.2, 404	Install door pull on the Inside of stall book (potentially install lock hardware on doors)	\$75
			(Right) Men's Toilet Room		signs designating bathroom with raised

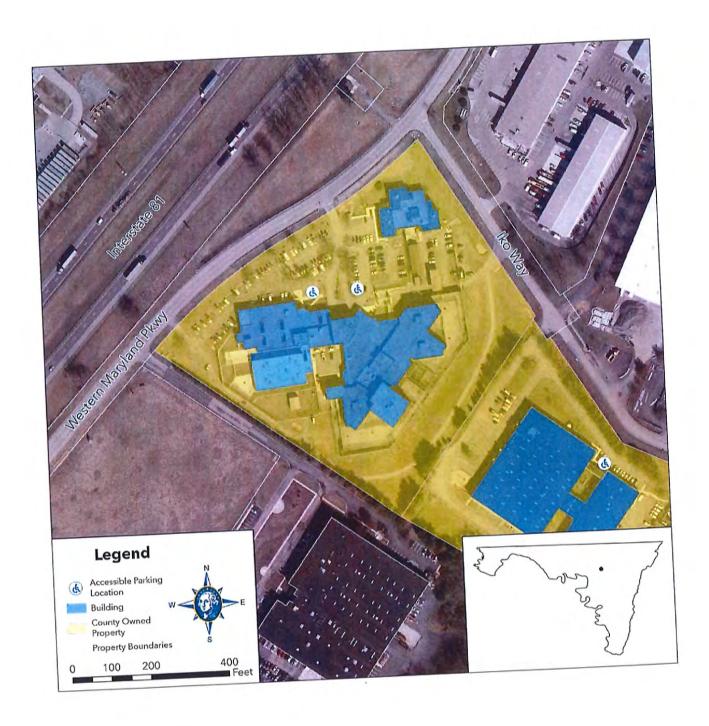
Washington County Government Accessibility Assessment Buildings / Facilities					
Onongs I commen			Washington County Sheriff Detention Center		
			500 Western Maryland Parkway, Hagerstown, MD 21740	740	
		Van Nato	Accessibility Deficiency	ADA Code Reference	Recommendation
Room / Space Parking	Priority 4H	S-9, S-2	No parking spaces are currently marked or identifyed as "van accessible". Access aisle is not marked as to discourage parking in it. Cross slope at accessible parking location exceeds 2.08% (3.8%).	502.6, 502.3.3, 502.4	Add signage designating a parking & as "van accessible" and marking & discouraging parking in accessible alsie. Ensure that accessible parking area slopes do not exceed 2.08% when repaved.
Exterior Accessible Route			stone of such ramp right flare exceeds 10.0% (11.7%).		Repair curb ramp so that flare slope does
Curb Ramps	44	\$-3	Sight of contrasting and	406.3	mot exceed 10.0%. Preferably and detectable warning surface.

Main Entrance					
Interior Accessible Route					
Ramps					in the light state of the state
Elevators	S.	A-9	No signage designating permant rooms and spaces not likely to change over time.	216 / 703	designating permant rooms and spaces not likely to change over time that has raised characters and braille in compliant locations.
0					Relocate controls throughout building to
Controls	6M	E	Light controls are located outside of 48" accessible reach from floor. (52")	308.2.1	locations within accessible reach range.
Fire Addition Systems					
Benches	-		Men's Toilet Room		The state of Apor Be
Toilet Room - Accessible Route	7M	₽	Sign is not located on latch side of door. There is not 18" of maneuverable clearance beyond latch side of door. Mirror height is greater than 40" minimum from floor (44"). Pipes below lavatory are not insulated or otherwise configured to protect against contact.	703.4.2, 404.2.4, 603.3, 606.5	Relocate sign to latch side of goor, resource mirror to compliant height. Install insulation or configure pipes below lavatory to protect against contact.

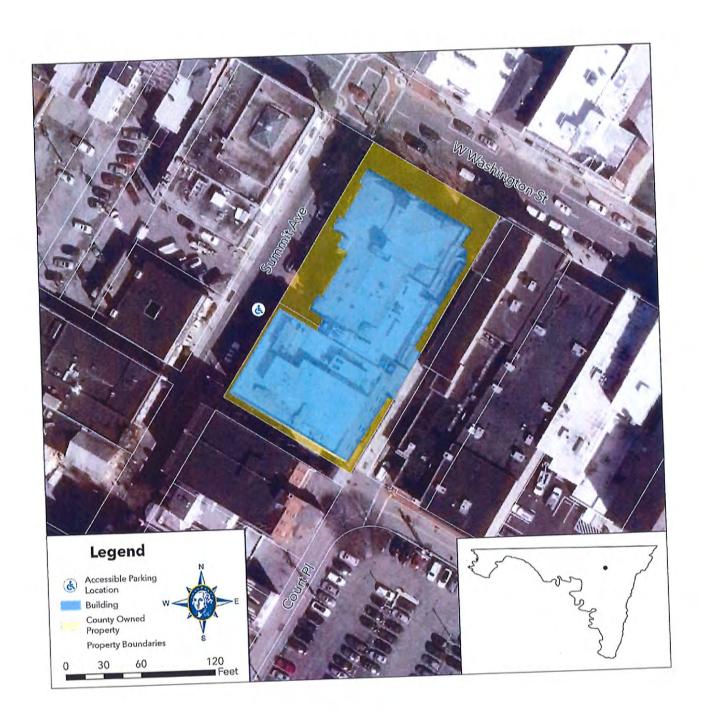
Washington County Court House

Toilet Room - Accessible Route 9L A-28 Coat hook height is greater than 48" from floor (62"). Soap Dispensers and Hand Dryers 9L A-25 Side wall (36.5") and rear wall (36.5") grab bars top of 604.5/609.4 Relocate grab bars so that top of gripping.	Room / Space	Accessibility Deficiency Accessibility Deficiency gns reading "Van Accessible" at accessible gns reading "Van Accessible" at accessible n. 1st Floor Men's Toilet Room ght is greater than 48" from floor (62"). 1st Floor Wenn's Toilet Room ght is greater than 48" from floor (62"). 1st Floor Women's Toilet Room ght is greater than 48" from floor (62"). 1st Floor Women's Toilet Room ght is greater than 48" from floor (62"). 1st Floor Women's Toilet Room ght is greater than 48" from floor (62"). 1st Floor Women's Toilet Room ght is greater than 48" from floor (62").	ADA Code Reference 502.6 502.6 604.5/703 216/703 216/703 216/703	Recommendation Install signage reading "Van Accessible" at accessible parking location. Install signage designating permanent rooms and spaces not likely to change over time at compliant height with raised characters and braille where needed. Lower coat hook height to within 48" from floor. Relocate grab bars so that top of gripping surface is within 36" above floor. Relocate toilet paper dispenser to compliant location in reference to water closet. Ensure that door pulls are installed on both sides of stall door. Relocate grab bars so that top of gripping surface is within 36" above floor. Ensure that door pulls are installed on both sides of stall door.

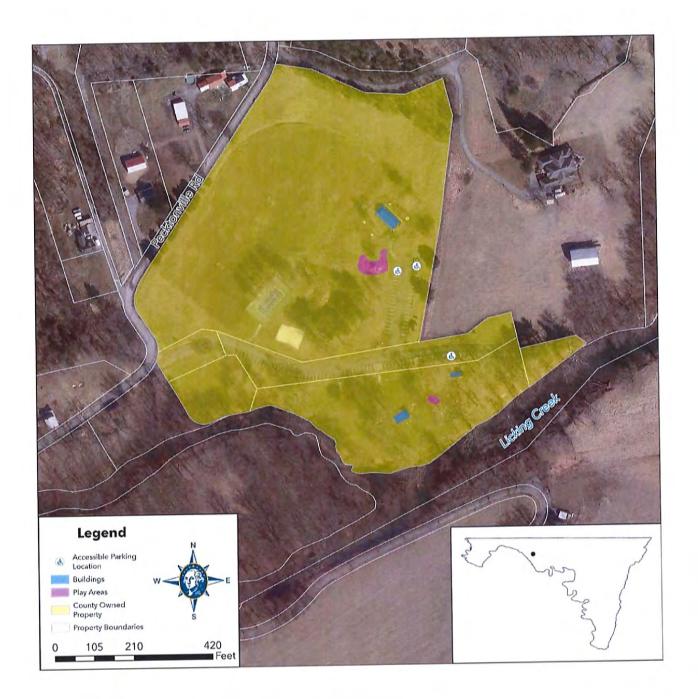
Camp Harding Park

1						Play Areas
						Service Counters
						Drinking Fountain
						Toilet Compartment (Stalls)
7	Protruding object will be moved to another location	604.5.1, 204	Less than 12" clearance between grab bar and protruding objects (4.5")	A-24	91	Water Closets

- 0	Soap Dispensers and Hand Dryers
-	correct location	603.4	Coat Hook greater than 48" above floor (60")	A-27	9L	Toilet Room - Accessible Route
			Women's Toilet Room			
						Toilet Compartment (Stalls)
	moved to another location	604.5.1, 204	Less than 12" clearance between grab bar and protruding objects (4.5")	A-24	92	Water Closets
						Soap Dispensers and Hand Dryers
	Coat hook will be moved to correct location	603.4	Coat Hook greater than 48" above floor (60")	A-27	J6	Toilet Room - Accessible Route
			Men's Toilet Room			
						Benches
						Seating
						Fire Alarm Systems
						Controls
						Signs
						Elevators
						Ramps
						Interior Accessible Route
						Main Entrance
Ш".						Curb Ramps
27	Redesign or reorient accessible route so that is is within compliant slope range.	403.3	Cross Slope greater than 2.08% (8.2%)	S-3	6M	Exterior Accessible Route
	Van Accessible signs will be installed	502.6	No "Van Accessible" sign at van accessible spaces.	S-9	6M	Approaches and Entrances

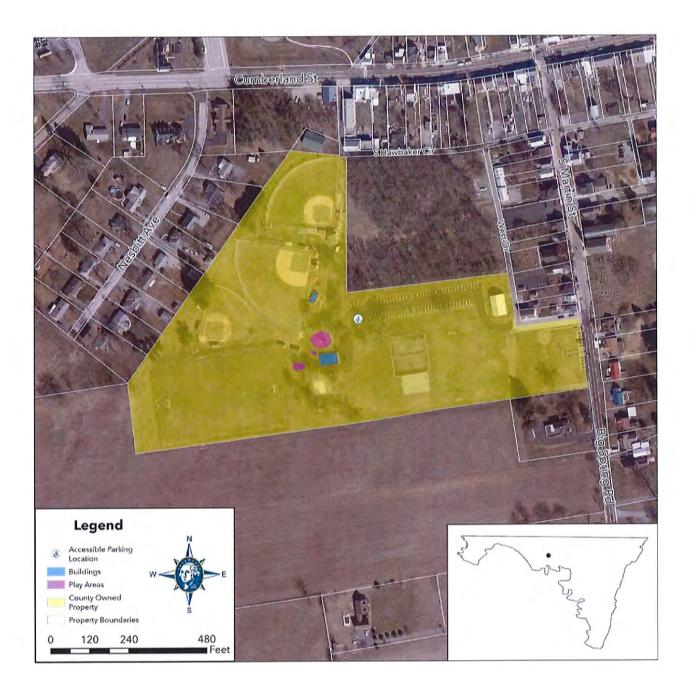
3 1	Toilet Compartment (Stalls)	Water Closets	Soap Dispensers and Hand Dryers	Toilet Room - Accessible Route		Benches	Seating	Fire Alarm Systems	Controls	Signs	Elevators	Ramps	Interior Accessible Route	Main Entrance	Curb Ramps	Exterior Accessible Route	Approaches and Entrances	Room / Space			Parks	Accessibility Assessment	Washington County Government
	9L	91		7M			-										6M	Priority					
	A-21	A-24, A-25		A-4, A-20, A-27													S-9	Key Note		Ī			
Woman's Tailat Boom	No door pull on outside of stall door.	Side grab bar located more than 12" from rear wall (13"). Less than 12" clearance between side grab bar and projecting objects above (3 1/2").		Floor surface on both sides of door is not level. Coat Hook greater than 48" above floor (60")	Men's Toilet Room												No "Van Accessible" sign at van accessible spaces. Access aisles are not marked as to discourage parking in them.	Accessibility Deficiency	12424 Big Spring Road Clear Spring, MD 21722	Clear Spring Park

604.8.2.2	604.5.1, 204		404.2.4.4 / 302, 603.4													502.6	ADA Code Reference	2				
	install door pull on outside of stall door.	Relocate side grab bar to compliant location. Projecting objects above side grab bar to be relocated to compliant location.		level floor surface. Coat hook will be moved to correct location.													Van Accessible signs and access aisle signs will be installed.	Recommendation					
	\$15	\$0		\$500													\$25	Cost

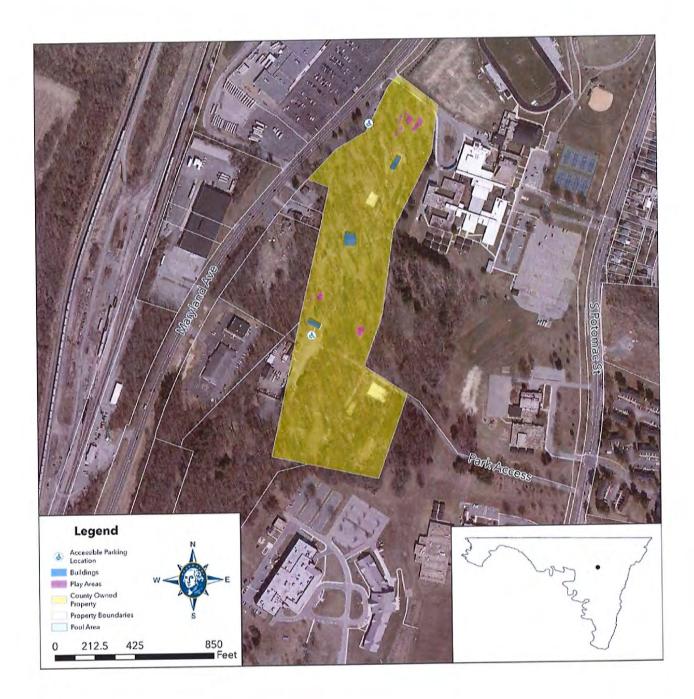
Doub's Woods Park

Right (South) Toilet Room		
\$10	Install door pull on interior side of stall door.	604.8.1.2	A-24	91	Toilet Compartment (Stalls)
\$0	Relocate grab bars to compliant location in reference to floor.	604.5/609.4	Top of sidewall grab bar gripping surfaces A-24, A-25 are greater than 36" above floor (side 37" - rear 37").	.91	Water Closets
					Soap Dispensers and Hand Dryers
					Toilet Room - Accessible Route
			Left (North) Toilet Room		
			Southern Pavilion Toilet Rooms		
\$10	Install door pull on interior side of stall door.	604.8.1.2	A-24 Door pulls are not located on both sides of door.	91	Toilet Compartment (Stalls)
\$0	Relocate side grab bar to compliant location in reference to rear wall.	604.5.1	Side wall grab bar is greater than 12" from A-24, A-25 rear wall (12.5").	92	Water Closets
					Soap Dispensers and Hand Dryers
					Toilet Room - Accessible Route
			Women's Toilet Room		
\$10	Install door pull on interior side of stall door.	604.8.1.2	A-24 Door pulls are not located on both sides of door.	JE	Toilet Compartment (Stalls)

\$0	compliant location in reference to floor.	604.5/609.4	A-24, A-25 are greater than 36" above floor (side 37" - rear 37").	91	Water Closets
					Soap Dispensers and Hand Dryers
					Toilet Room - Accessible Route
			Men's Toilet Room		
			Arts Pavilion Toilet Rooms		
\$10	Install door pull on interior side of stall door.	604.8.1.2	A-24 door.	JE	Toilet Compartment (Stalls)
\$0	Relocate grab bars to compliant location in reference to floor.	604.5/609.4	Top of sidewall grab bar gripping surfaces A-24, A-25 are greater than 36" above floor (side 36.5" - rear 37").	91	Water Closets
					Soap Dispensers and Hand Dryers
					Toilet Room - Accessible Route
			Right (West) Toilet Room		
\$10	Install door pull on interior side of stall door.	604.8.1.2	A-24 Door pulls are not located on both sides of door.	JE	Toilet Compartment (Stalls)
\$0	Relocate grab bar to compliant location in reference to water closet.	604.5.2	Rear wall grab bar does not extend at least A-24, A-25 12" towards sidewall from water closet centerline.	91	Water Closets

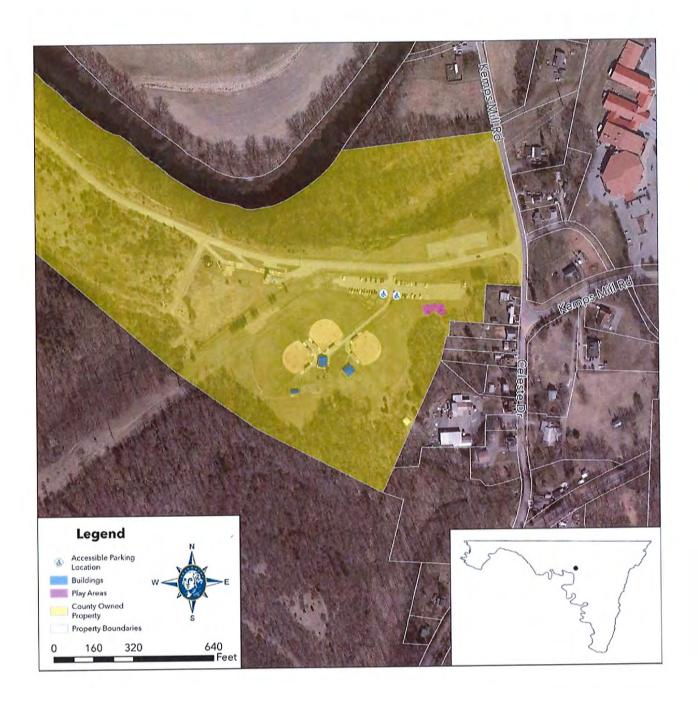
Washington County Government Accessibility Assessment						
Parks						
			Kemps Mill Park			
			11114 Kemps Mill Road Williamsport, MD 21795)5		
Room / Space	Priority	Key Note	Accessibility Deficiency	ADA Code Reference	Recommendation	Cost
Approaches and Entrances	6M	9-5	No "Van Accessible" sign at van accessible spaces. Access aisles are not marked as to discourage parking in them.	502.6	Van Accessible signs and access aisle signs will be installed.	\$25
Exterior Accessible Route						
Curb Ramps						
Main Entrance						
Interior Accessible Route						
Ramps						
Elevators						
Signs						
Controls						
Fire Alarm Systems						
Seating						
Benches	7M	A-18	Bench seat less than 20-24" deep (18"). Bench seat height less than 17-19" A.F.F. (16").	903.3, 903.5	dimensions.	
			Men's Toilet Room		-	
Toilet Room - Accessible Route	7M	A-4, A-9, A 20, A-23	Signs do not h braille. Sign n side of the doo 48-60" A.F.F. (more than 1/2 higher than 3-4	404.2.4.4 / 302, 603.4	Install signage at compliant location. Replace door threshold with one less than 1/4" high. Lower lavatory to compliant height.	\$500

Soap Dispensers and Hand Dryers	91	A-24	Soap dispenser is located higher than 48" accessible reach range (49.5"). Hand dryer/towel dispenser is located higher than 44" accessible reach range (45").	606.1	Relocate soap dispenser to compliant height. Relocate hand dryer/towel dispenser to compliant height.

604.5.1, 204		404.2.4.4 / 302, 603.4		604.8.2.2	604.5.1, 204
compliant location. Relocate rear grab bar to compliant location. Relocate location. Relocate toilet paper dispenser to compliant location.		Install signage at compliant location. Replace door threshold with one less than 1/4" high. Rearrange/reorient location of hand dryer to allow a 36" clear path to lavatory. Provide a 60" wheelchair turn around space. Lower mirror to compliant height. Lower Coat hook to compliant height.		Lower door pull on outside of stall door to compliant height. Install lock hardware that doesn't require tight grasping, pinching, or twisting of the wrist.	Relocate rear grab bar to compliant location. Relocate toilet paper dispenser to compliant location.
\$0	4 1-1	\$500		\$15	\$0

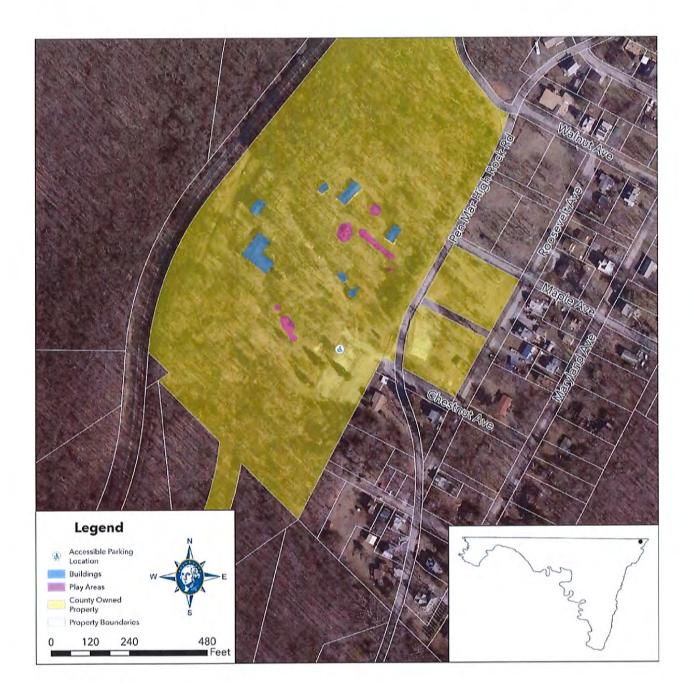
Soan Dispensers and Hand Drivers	Toilet Room - Accessible Route		Benches	Seating	Fire Alarm Systems	Controls	Signs	Elevators	Ramps	Interior Accessible Route	Main Entrance	Curb Ramps	Exterior Accessible Route	Approaches and Entrances	Room / Space			Parks	Accessibility Assessment	Washington County Government
	9L		7M											4H	Priority		-			
	A-27		A-18											S-2, S-9	Key Note	1.	İ			
	Coat hook is located outside of 48" accessible reach range from floor (62").	Men's Toilet Room - Western	Bench seat are less than 17" minimum above ground (15").											Insufficant spaces - 2 p spaces). No accessible (3.8%). No van accessi	Accessibility Deficiency	14600 Pen Mar Road, Highfield-Cascade, MD 21719	Pen Mar Park

604.8.3		903.5											208.2, 502.3, 502.4, 502.6	ADA Code Reference	9				
	location within accessible reach range.		or replace park benches.	Adirect hoight of park hanche										Ensure that there are 3 designated accessible parking space with an access aisle with proper signage. Elevated pavement to ensure that slope at accessible parking location is less than 2.08%.	Recommendation					
	\$0		\$5,000											\$1,500	Cost

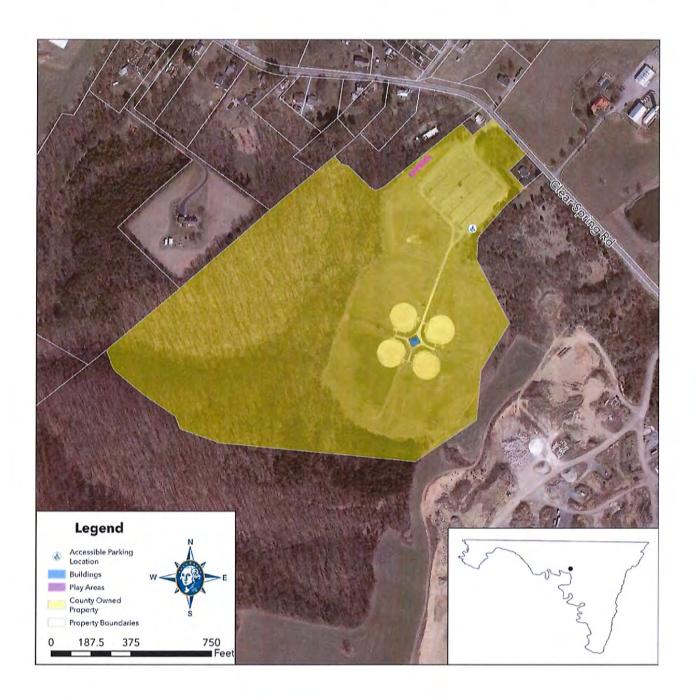
Soap Dispensers and Hand Dryers	Toilet Room - Accessible Route		Benches	Seating	Fire Alarm Systems	Controls	Signs	Elevators	Ramps	Interior Accessible Route	Main Entrance	Curb Ramps	Exterior Accessible Route	Approaches and Entrances	Room / Space			Parks	Accessibility Assessment	Washington County Government
16	7M													6M	Priority					
A-24	A-2, A-4, A 9, A-12, A- 20, A-21, S 9													S-2, S-3, S- 9, S-10	Key Note	15	-			
Soap dispenser is located higher than 48" accessible reach range (52.5").	Signs do not have raised text characters or braille. Sign mounted higher than 48-60" A-2, A-4, A-A.F.F. (68.5"). Floor surface on both sides of 9, A-12, A- door is not level. Door threshold edge more 20, A-21, S-than 1/4" high (1"). Door hardware requires tight grasping, pinching, or twisting of the wrist.	Men's Toilet Room												No "Van Accessible" sign at van accessible S-2, S-3, S- spaces. No Access aisles marked. 9, S-10	Accessibility Deficiency	15323 Clear Spring Road Williamsport, MD 21795	Pinesburg Softball Complex

606.1	404.2.4.4 / 302, 603.4													502.6	ADA Code Reference	5				
Relocate soap dispenser to compliant height.	Install signage at compliant location. Fill-in gap at door to create level floor surface. Replace door threshold with one less than 1/4" high. Replace door hardware.													Van Accessible signs and access aisle signs will be installed. Paint/mark access aisles.	Recommendation					
	\$500													\$25	Cost

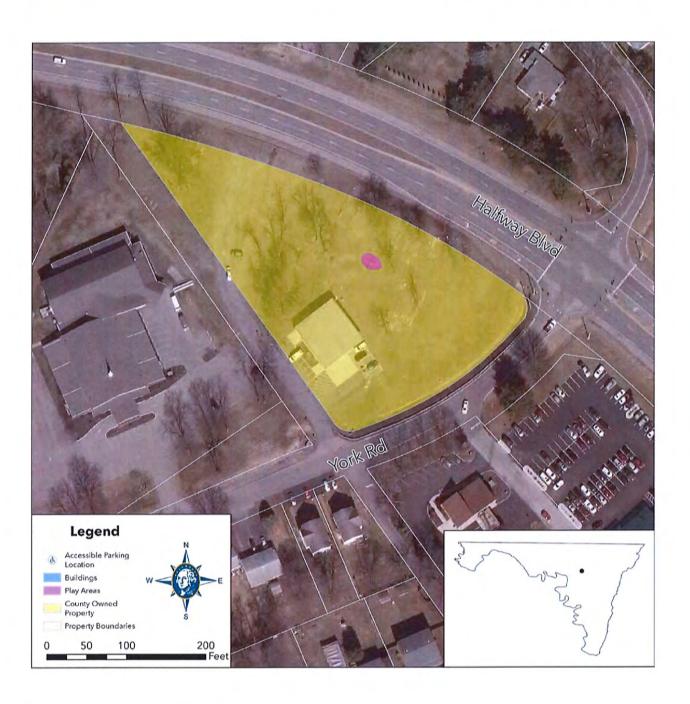
Play Areas	Service Counters	Drinking Fountain	Toilet Compartment (Stalls)	Water Closets	Soap Dispensers and Hand Dryers	Toilet Room - Accessible Route	Benches 7M A-18 bench is greater than 19" above ground 903.3, 903.5 (24").	Seating	Fire Alarm Systems	Controls	Signs 6M S-9 No signage present. 216 / 703	Elevators	Ramps	Interior Accessible Route	Main Entrance	Curb Ramps	Exterior Accessible Route 2H S-3 area or fixtures. No present accessible paved path to play 206 / 403	Approaches and Entrances 2H S-2, S-9 parking or accessible parking. 208 / 502	Room / Space Priority Key Note Accessibility Deficiency ADA Code Reference	Piper Lane Neighborhood Park 17556 York Road, Hagerstown, MD 21740	Parks

903.3, 903.5				216 / 703						206 / 403	208 / 502	A Code Reference			
Total							Replace park bench.				Install compliant accessible signage throughout park where needed.						Pave compliant accessible route to park fixtures and play area.	Pave parking area with accessible parking location.	Recommendation			
\$51,250							\$1,000				\$250						\$10,000	\$40,000	Cost

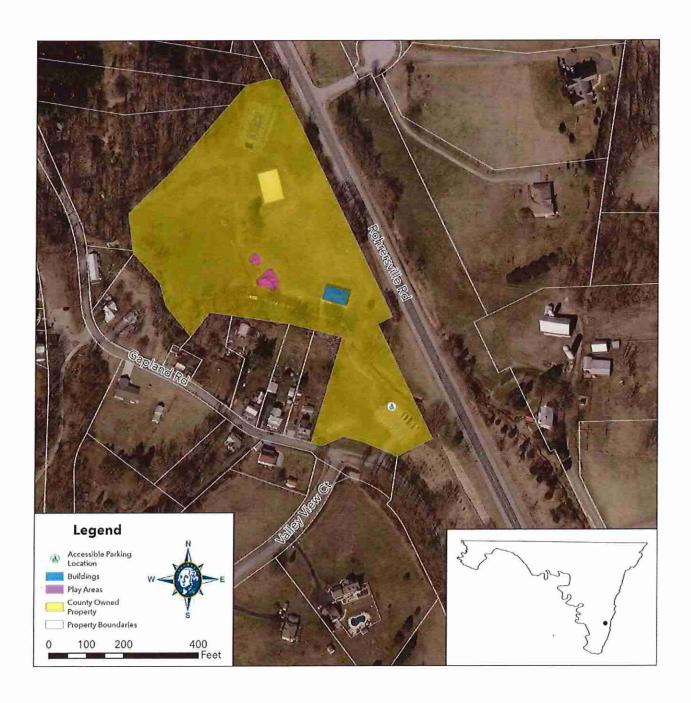
Pleasant Valley Park

lnstall signage on latch side of door.		door (only on outside of stall door). Women's Toilet Room Sign is not mounted on latch side of door.	S-9	9L	Toilet Room - Accessible Route
e of s	Relocate grab bars to location where the top of gripping surface is less than 36" from floor. Install door pull on inside of stall	604.8.2.3 / 609.4		A-24, A-25 A-20	9F 5F	Water Closets Toilet Compartment (Stalls)
2	ilistali signage on accil side oi dooi.		offine monited on factions of donit.	S-9	9L	Toilet Room - Accessible Route Soap Dispensers and Hand Dryers
			Men's Toilet Room			
						Benches
						Seating
						Controls
						Signs
						Elevators
						Ramps
						Interior Accessible Route
						Main Entrance
						Curb Ramps
6 3 81	Repave routes throughout park so that they are firm, stable, and slip-resistant. Ensure that surface slopes are compliant.	302	Exterior routes throughout park are not stable, firm, and slip-resistant.	S	2Н	Exterior Accessible Route

22 21 21	Repave and remark accessible parking area so that slopes are in compliance. Provide complaint signage to mark accessible parking area and access aisle.	208/502, 502.4/302	There is no signage currently marking the accessible parking area. The slope in the accessible parking area exceeds 2.08% (2.8%).	S-9, S-2	2H	Approaches and Entrances

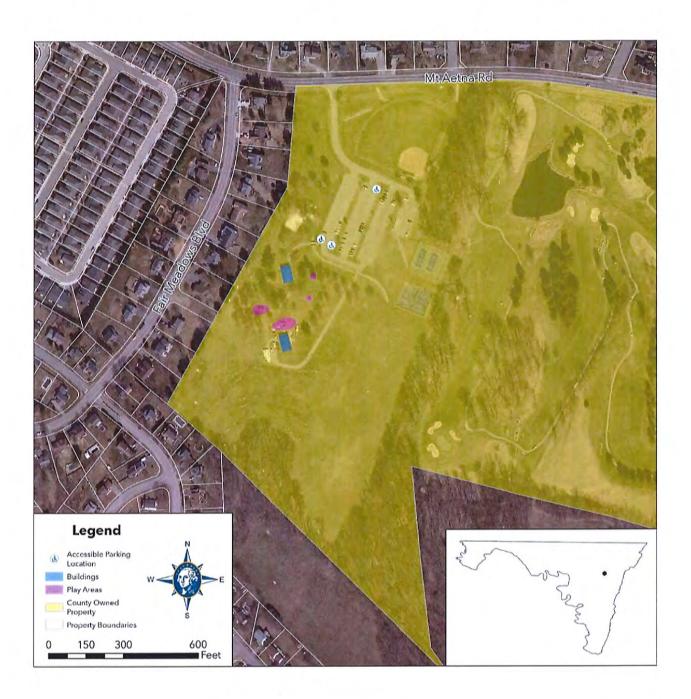
Benches	Seating	Fire Alarm Systems	Controls	Signs	Elevators	Ramps	Interior Accessible Route	Main Entrance	Curb Ramps	Exterior Accessible Route	Approaches and Entrances	Room / Space			Parks	Accessibility Assessment	Washington County Government
					6M						6M	4Н	Priority					ent
					S-9						S-3	S-2, S-9	Key Note					
Men's Toilet Room - Lower Pavilion					No signage present.						Cross slope of accessible route exceeds 2.08% (3.4%).	No access aisles or signage present for access aisles present. Slope in accessible parking area exceeds 2.08% (2.6%).	Accessibility Deficiency	20025 Mount Aetna Road, Hagerstown, MD 21742	Regional Park			
					216 / 703						302/206	502.3, 502.3.3, 502.4/302	ADA Code Reference	1742				
					Install compliant accessible signage throughout park where needed.						Pave or alter surface so that route surface has a compliant slope.	Remark/paint accessible parking area to allow for access aisles. Install relevant signage for access aisle. Ensure that slope in area is compliant.	Recommendation

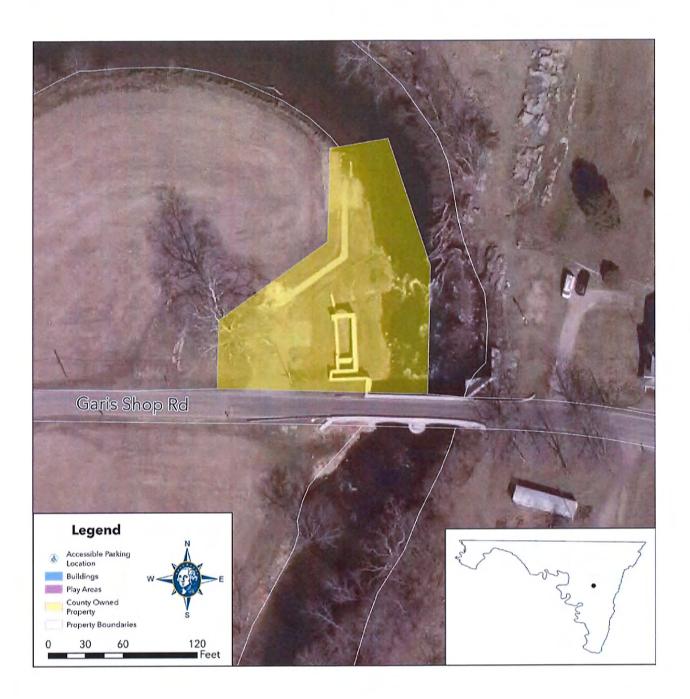
Play Areas	Service Counters	Drinking Fountain	Toilet Compartment (Stalls)	Water Closets	Soap Dispensers and Hand Dryers	Toilet Room - Accessible Route	Benches	Seating	Fire Alarm Systems	Controls	Signs	Elevators	Ramps	Interior Accessible Route	Main Entrance	Curb Ramps	Exterior Accessible Route	Approaches and Entrances	Room / Space		Parks	Accessibility Assessment	Washington County Government
											6 M						31	2H	Priority				
											S-9						S-3	S-2, S-9	Key Note				
											No signage present.						The route surface is not stable, firm, and slipresistant.	No parking area designated as accessible and no access aisle present.	Accessibility Deficiency	Rose's Mill Park 10010 Garis Shop Road, Hagerstown, MD 21740			
											216 / 703						302.1	208 / 502	ADA Code Reference	0			
											Install compliant accessible signage throughout park where needed.						Pave or alter surface so that route surface is stable, firm, and slip-resistant.	Mark area of parking as accessible and designate a access aisle. Add compliant signage to designate area as accessible.	Recommendation

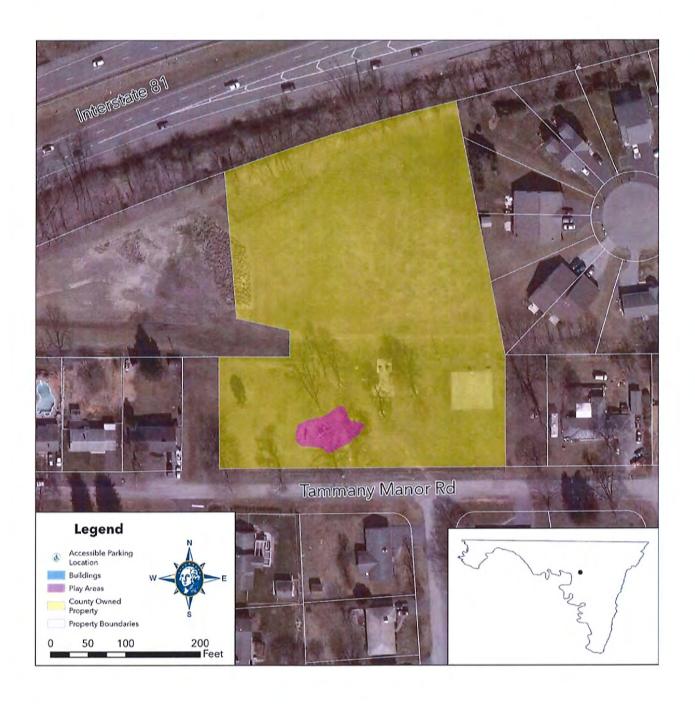
Play Areas	Service Counters	Drinking Fountain	Toilet Compartment (Stalls)	Water Closets	Soap Dispensers and Hand Dryers	Toilet Room - Accessible Route	Benches	Seating	Fire Alarm Systems	Controls	Signs 6M	Elevators	Ramps	Interior Accessible Route	Main Entrance	Curb Ramps	Exterior Accessible Route 2H	Approaches and Entrances	Room / Space Priority			Parks	Accessibility Assessment
												5-9						2	\$22	Key Note				1
												Park does not have accessible signs designating permanent areas or spaces not likely to change overtime.						Paved walking path throughout park does not have a stable, firm, or slip-resistant surface.	Only street parking is available, no area of street parking is marked or designated as accessible parking.	-	16700 Tammany Manor Road, Williamsport, MD 21795	Tammany Park		
												216 / 703						206 / 403	208 / 502	ADA Code Reference				
Total												Install signage designating permanent area and spaces not likely to change overtime with braille and raised characters at compliant heights.						Repave pathway with stable, firm, and slip resistent surface, ensuring that slopes are compliant to allow for an accessible route to all park fixtures.	Install signage and pave shoulder to Tammany Manor Drive and add markings to designate area as accessible parking.	Recommendation

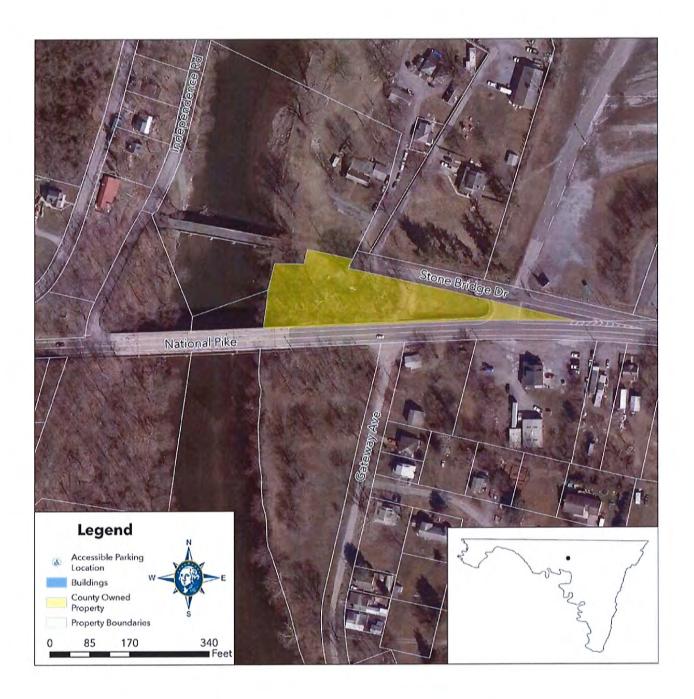
Play Areas	Service Counters	Drinking Fountain	Toilet Compartment (Stalls)	Water Closets	Soap Dispensers and Hand Dryers	Toilet Room - Accessible Route	Benches	Seating	Fire Alarm Systems	Controls	Signs	Elevators	Ramps	Interior Accessible Route	Main Entrance	Curb Ramps	Exterior Accessible Route	Approaches and Entrances	Room / Space			Parks	Accessibility Assessment	Washington County Government
											6M						2H	2Н	Priority					
											S-9						£	5-2	Key Note					
											Not present throught park area.						Current routes to water/bridge are not traversable and are currently being overgrown by vegitation.	There is no parking area designated as an accessible parking area.	Accessibility Deficiency	15032 National Pike, Hagerstown, MD 21740	Wilson Bridge Picnic Area			
											216						206	502	ADA Code Reference					
Total											Install signage as needed.						Repave accessible routes so that they are traversable and ensure that routes are ADA compliant.	Ensure compliant surface slopes, mark spaces and provide signage for accessible parking area.	Recommendation

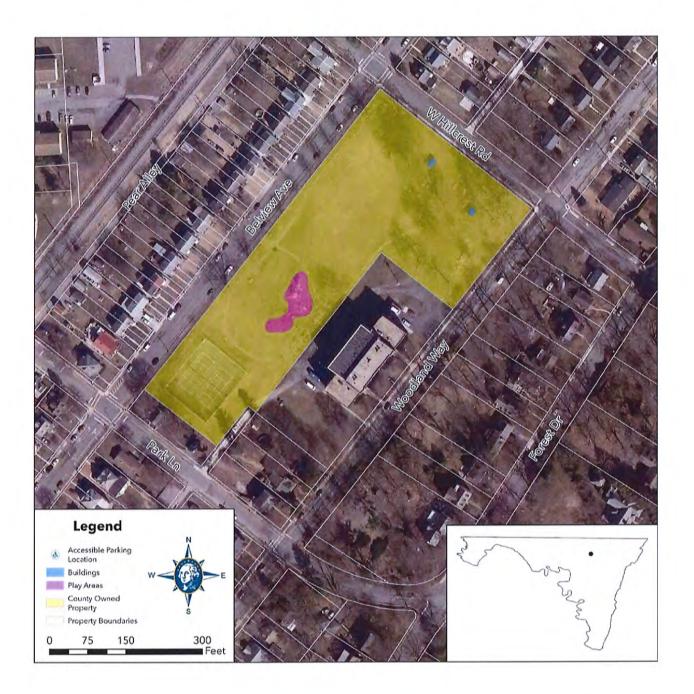
Play Areas	Service Counters	Drinking Fountain	Toilet Compartment (Stalls)	Water Closets	Soap Dispensers and Hand Dryers	Toilet Room - Accessible Route	Benches	Seating	Fire Alarm Systems	Controls	Signs	Elevators	Ramps	Interior Accessible Route	Main Entrance	Curb Ramps	Exterior Accessible Route	Approaches and Entrances	Room / Space			0.00	Parks	Washington county government
												6M		2Н			2H	2H	2Н	Priority					
												6-5		S-7			57	Ω	S-2	Key Note					İ
												Park does not have accessible signs designating permanent areas or spaces not likely to change overtime.		Areas of pathway have topography that would require a ramp and no designated ramps are present:			Entrance from parking area is not accessible.	Paved walking path throughout park does not have a stable, firm, or slip- resistant surface. The path is not compliant with running and cross slope regulations at multiple points throughout park. Path is narrower than 60" and does not include passing zones.	Only street parking is available, no area of street parking is marked or designated as accessible parking.	Accessibility Deficiency	108 Belview Avenue, Hagerstown, Md 21740	Woodland Way Neighborhood Park

216 / 703		405			206, 406	206 / 403	208/502	ADA Code Reference					
Total											c	Install signage designating permanent area and spaces not likely to change overtime with braille and raised characters at compliant heights.		Designate areas of park pathway as ramps and ensure that landing zones and harndrails are installed as needed.			Install curb ramp at entrance from street parking (near pathway roundabout & park sign).	Repave pathway with stable, firm, and slip resistent surface, ensuring that slope are compliant with handrails and passing zone where needed. (approx. 7,750 sq ft)	Install signage and add pavement marking to designate area as accessible parking.	Recommendation					
\$95,900												\$500		\$10,000			\$5,000	\$80,000	\$400	Cost					1
