WASHINGTON COUNTY, MARYLAND

ADA SELF EVALUATION

BUILDINGS, FACILITIES, AND PARKS

2023 UPDATE

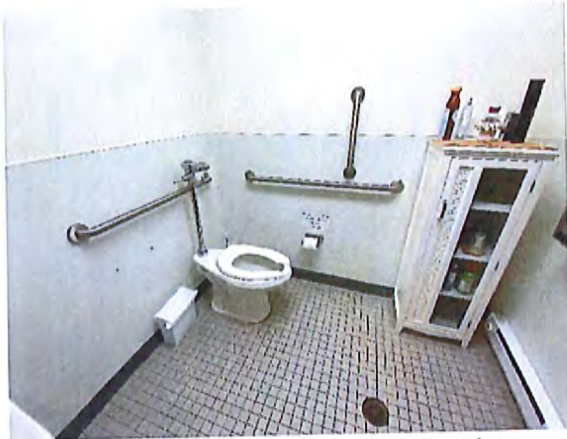
Women's Toilet Room Water Closet

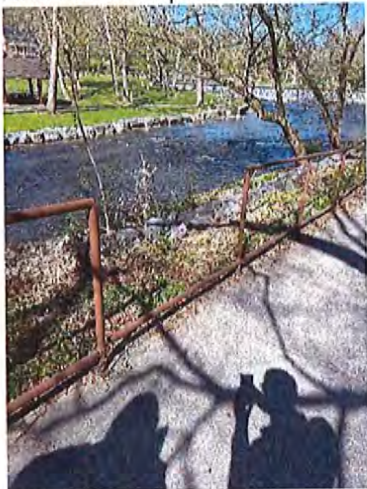
Broken Portion of Handrail on Pathway on Eastern Side of Bridge

Washington County Government						
Accessibility Assessment						
Parks						
Devil's Backbone Park						
18934 Lappans Road Boonsboro, MD 21713						
Room / Space	Priority	Key Note	Accessibility Deficiency	ADA Code Reference	Recommendation	Cost
Approaches and Entrances	4H	S-2, S-9	Access aisle is not marked so as to discourage parking in it. Running slope of accessible parking area exceeds 2.08% (2.5%).	502.3.3, 502.4 / 302	Provide signage that discourages parking in the access aisle. Level out slope so that it is withing compliant range.	\$5,000
Exterior Accessible Route	3H	S-3	Running slope of exterior accessible route (from accessible parking to bridge) exceeds 5.0% (10.0%).	206 / Ch. 4	Redesign or reorient accessible route so that is is within compliant slope range.	\$10,000
Curb Ramps						
Main Entrance						
Interior Accessible Route						
Ramps	3H	S-7, S-8	Handrail is not continous and has an area obstructed/damaged by a fallen tree.	505.4, 505.3	Replace handrails.	\$5,000
